James Walker	Title: Hygienic Clamp Inspection	Date: May 31, 2016 Reaffirmed 2022	Rev: 1	Page: Page 1 of 6	Document No: SIP03 Approved by: Quality Team
---------------------	------------------------------------------------	-------------------------------------------------	------------------	-----------------------------	---------------------------------------------------------------------

General Overview

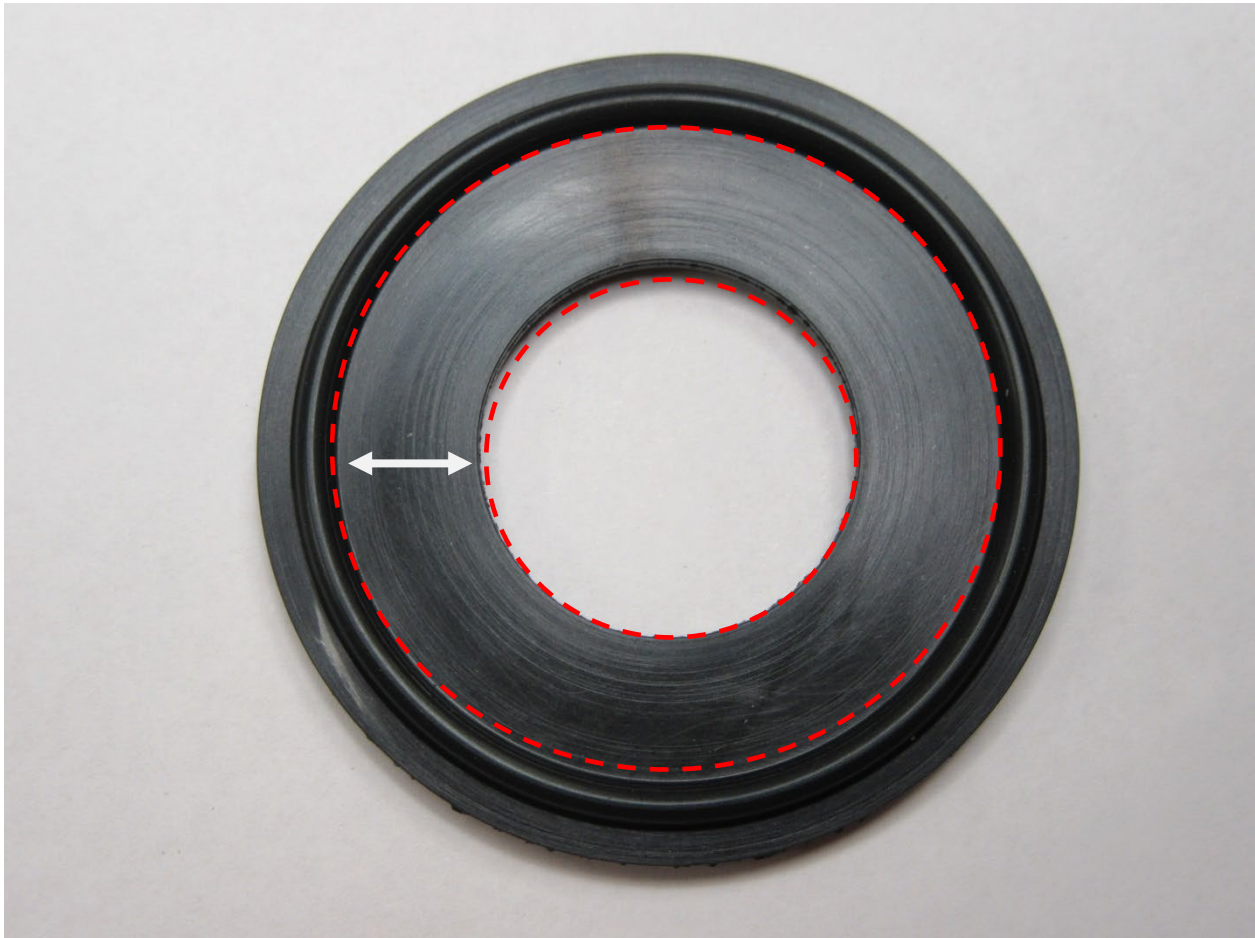
This document should be referred to as a guide during the inspection of hygienic clamp seals. The guide should be used along with the DJ and Drawing. The photograph below shows a general view of the seal and its main features.

Area indicated between dotted lines is the critical sealing surface, including inside diameter. Other areas are non-critical. They are to be visually inspected using good lighting, 2 X magnification is not required unless to verify defect type.

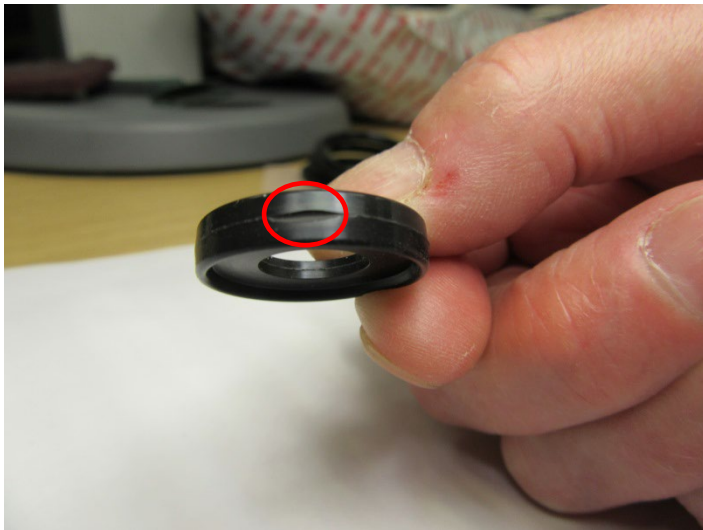
This shows torn flash on the OD which is too deep and not acceptable.

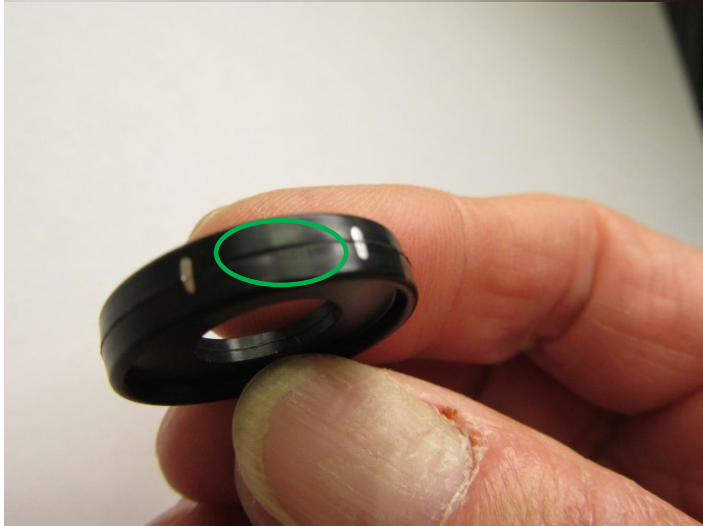
This shows torn flash on the OD which has no depth and is acceptable.

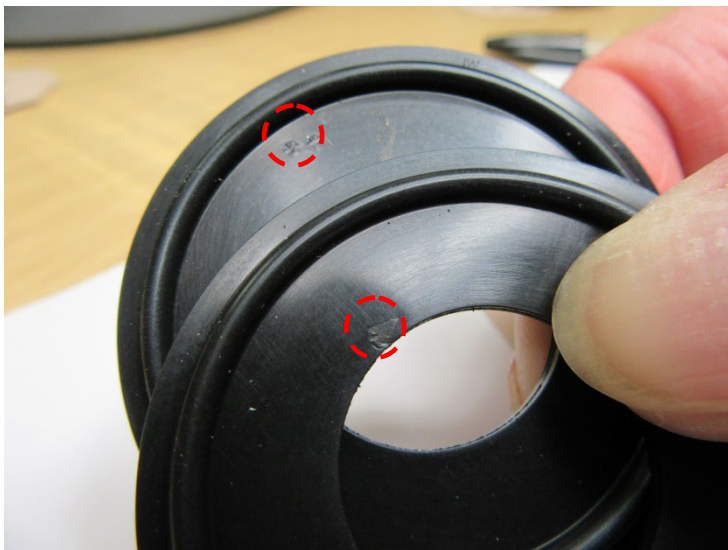
Poor Surface finish on sealing area, not acceptable.

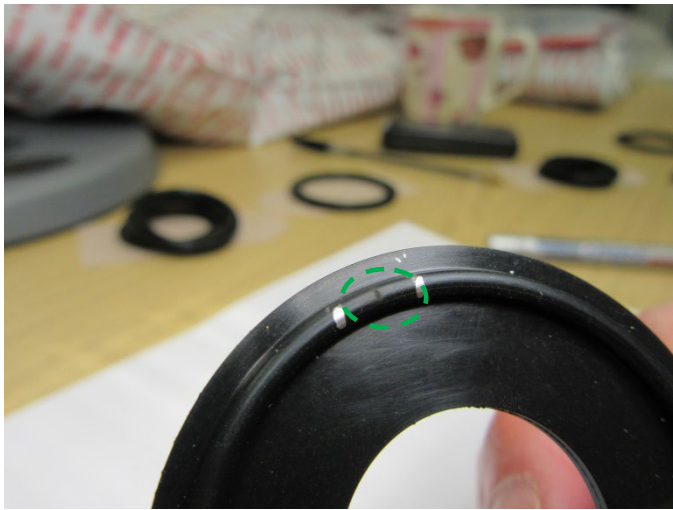
Surface blemish on non-critical area, this is acceptable.

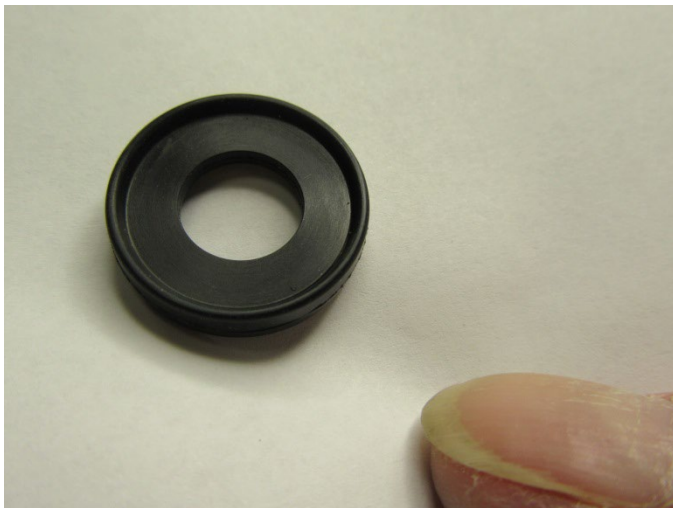
Good surface finish on Sealing area and no excess flash on ID.

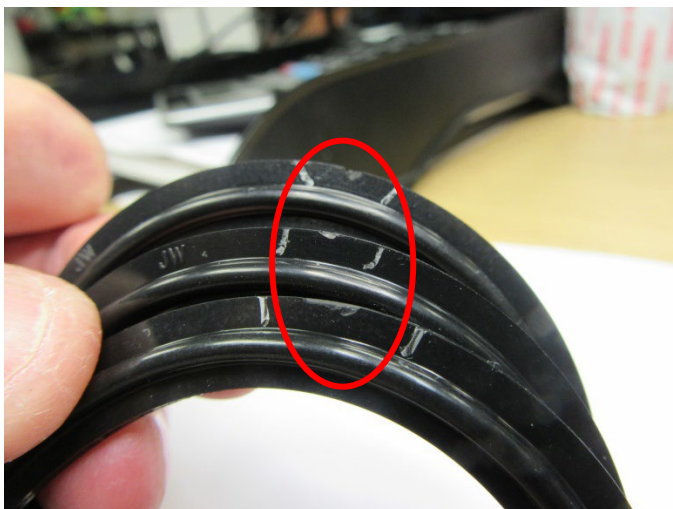
Breaking away on non-critical area, excessive depth, unacceptable.

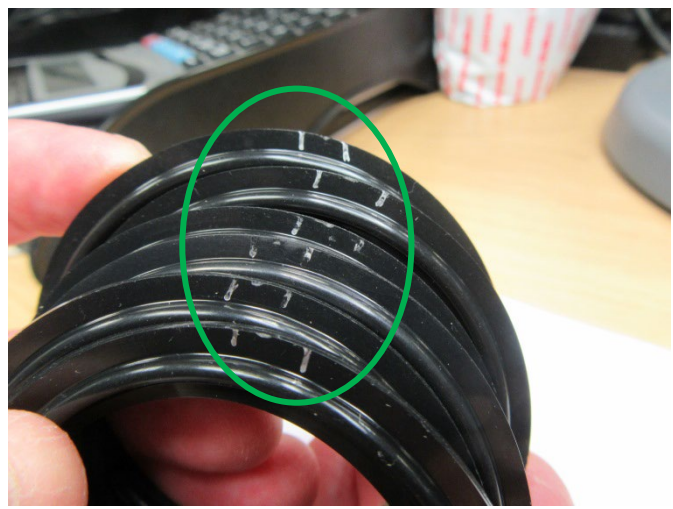
Breaking away on non-critical area, minor depth, acceptable.

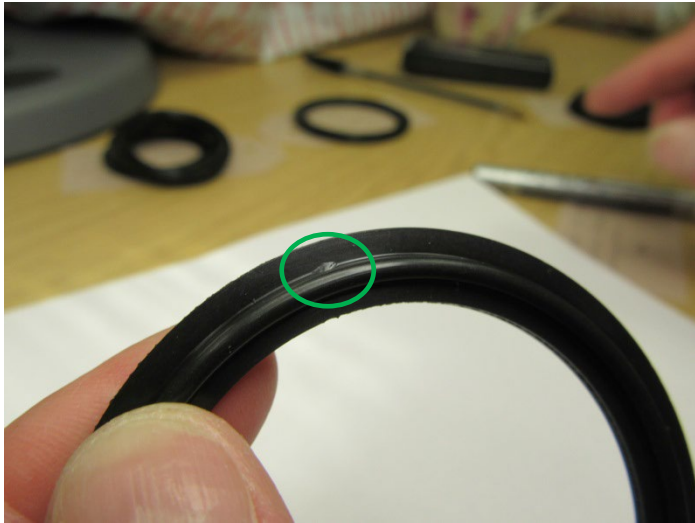
Damaged tool mark on non-critical sealing area, this is acceptable.

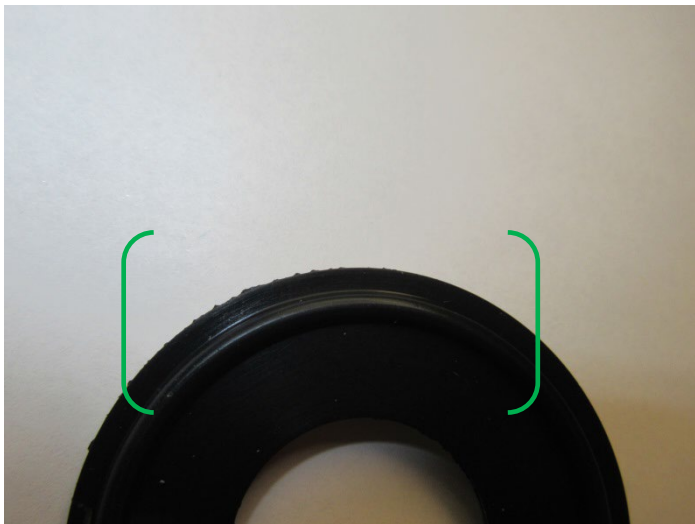
Small amount of excess flash is permitted on OD.

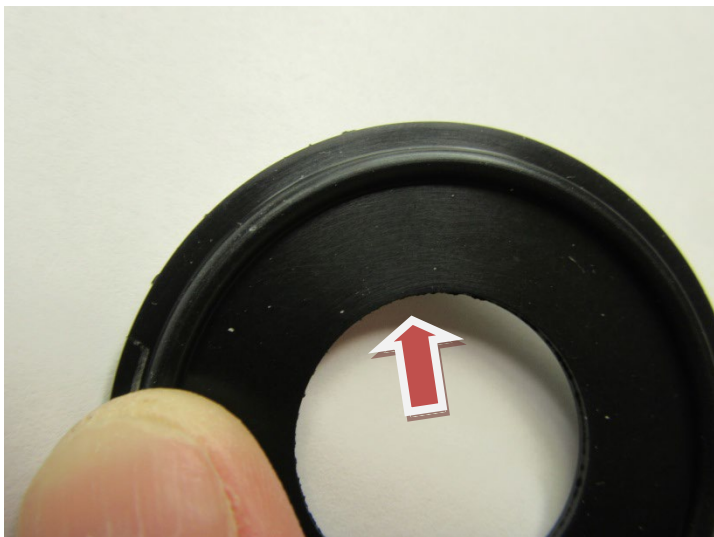
Excess flash on ID is not permitted.

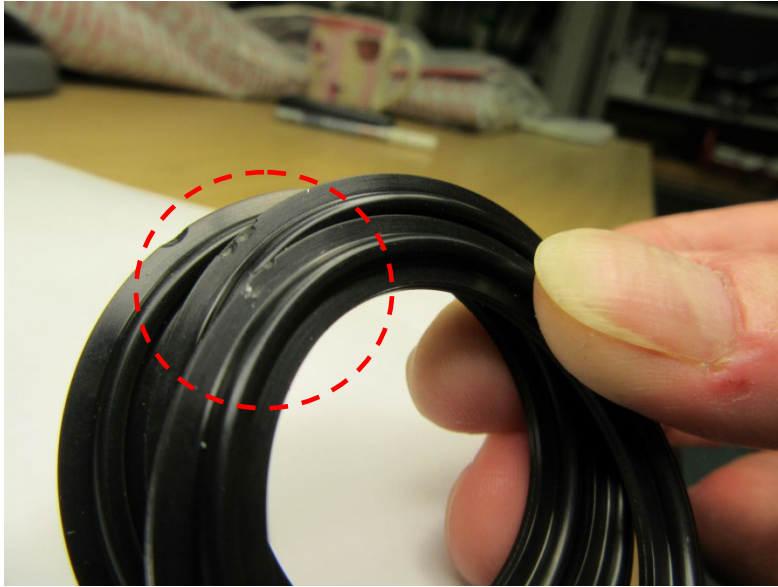
Chipped OD from CRYO trimming, this is not acceptable.

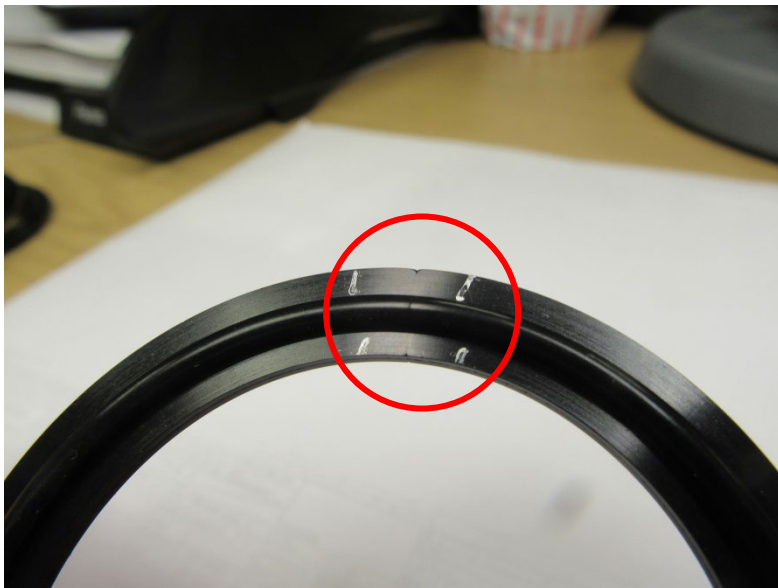
Poor flow of material at moulding stage, not completed in cavity, appears on both sides of seal, this is not acceptable.
