James Walker	Title: IK NORWAY RECTANGULAR SQUARE SECTION VISUAL INSPECTION GUIDE	Date: Mar 06, 2024	Rev: 1	Page: Page 1 of	Document No: SIP 16 Approved by: Quality Team
--------------	---	----------------------------------	----------------------	-------------------------------	--

This document should be referred to as a guide during inspection of any IK NORWAY CMRD3260369 RECTANGULAR SQUARE SECTION seals. This procedure should be used in conjunction with any other inspection standard referenced on the DJ and item Drawing JWC-FP-220528. (Customer DRG 3217611)

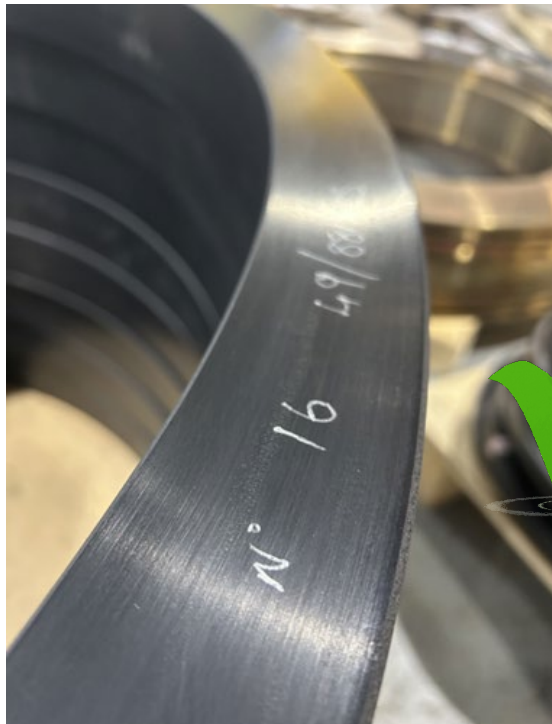
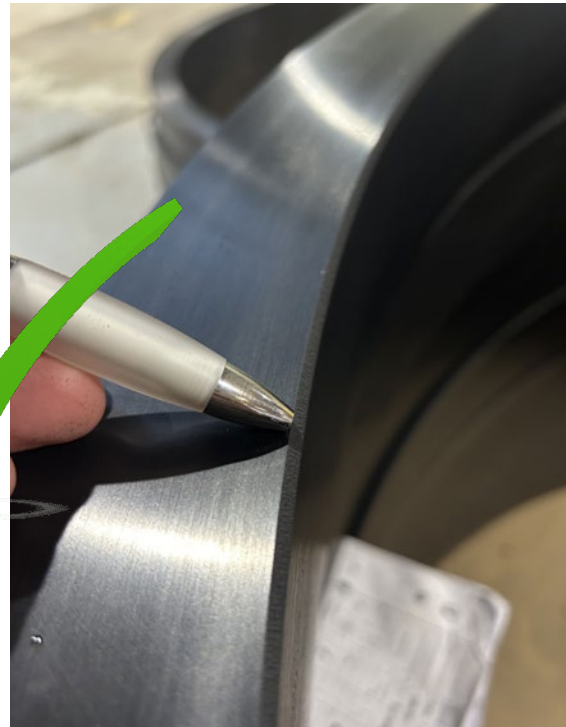
Image 2 & 3: Clean/blank chamfer – all evidence of backrind successfully removed **ACCEPTABLE.**

As per Images 2-7, evidence of backrind is permissible after an applied MAX 6mm chamfer.

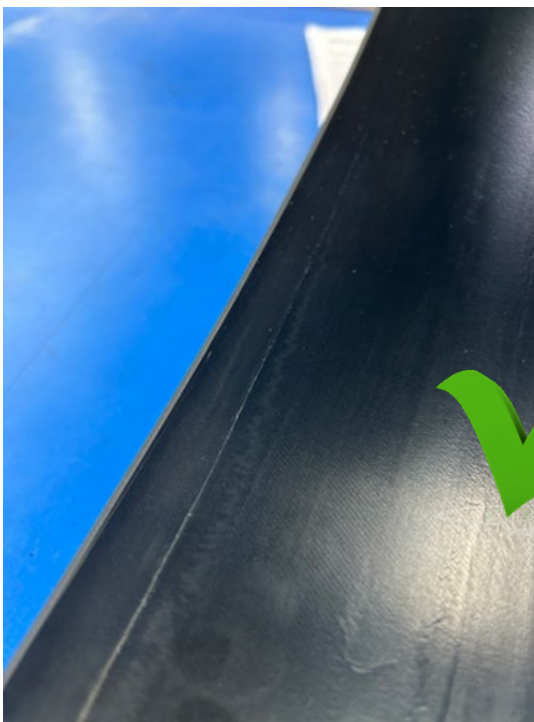
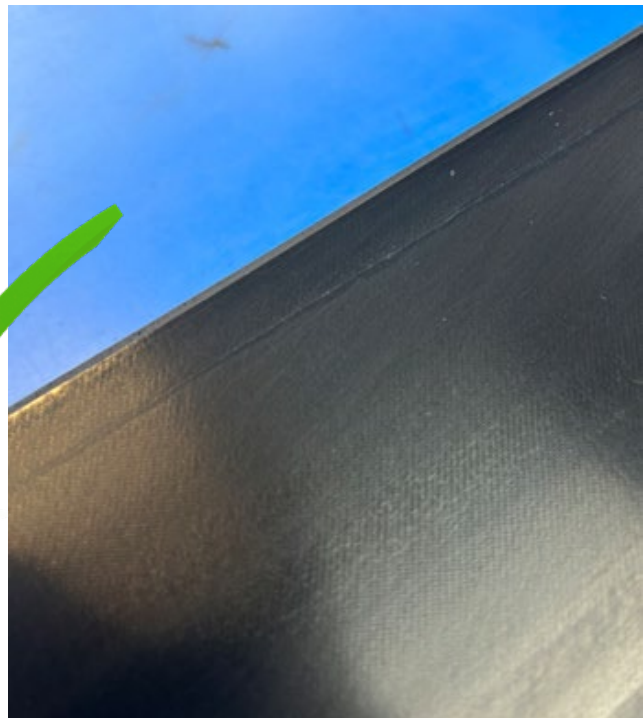
As per Images 9-12, evidence of creasing and flow marks is permissible, providing it has been manipulated in a way that the crease doesn't open up to a split. **SPLITS are not permissible.**

It is common for FLOWMARKS / CREASES to present on the seal, customer have acknowledged and agreed a level of acceptance. See photographs for pass fail criteria.

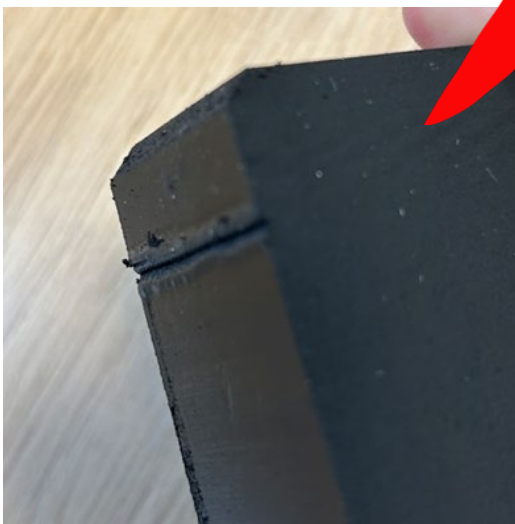
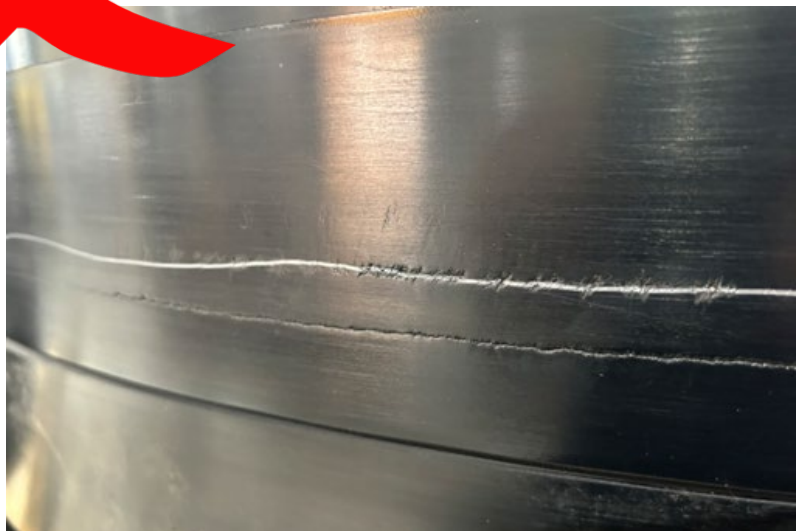
As per images 14-15, Crease imperfection approximately 1 – 1.5 mm. This level of imperfection is **rejectable** however It is permissible to dress these imperfections.

If an imperfection on image 15-17 can be dressed to the level of imperfection on a 11-14 image, This is then acceptable.

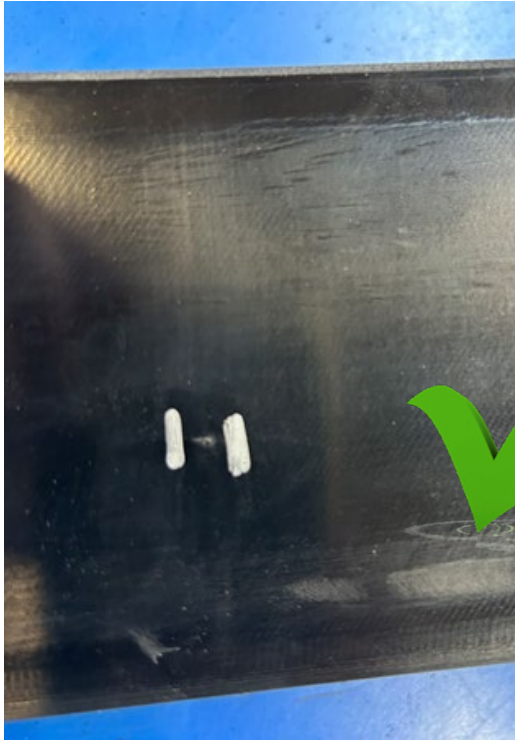
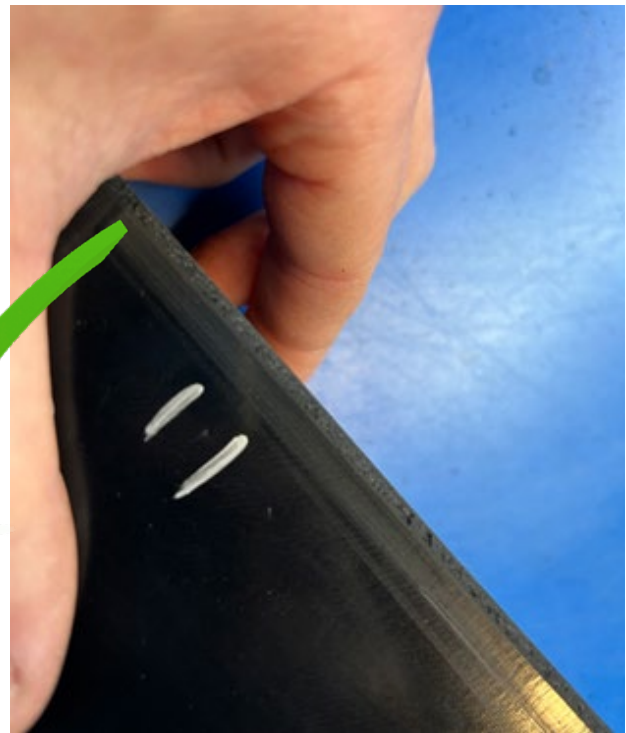
As per Images 16-17, evidence of non-fill imperfections is permissible, approximate length varying between 2 – 5 mm.

It is common for NON FILL to present on the seal, customer have acknowledged and agreed a level of acceptance. See photographs for pass criteria.

These types of imperfections are to be left as moulded and not cleaned up unless customer advises otherwise.
