James Walker	Title:	Date:	Rev:	Page:	Document No: SIP01
	Hygienic Diaphragm Inspection	Apr 28, 2016	1	Page 1 of 4	Approved by:
	Trygleriic Diapriragiii irispection	Apr 20, 2010	'	rage ror4	Quality Team

General Overview

This document should be referred to as a guide during inspection of Hygienic Diaphragm's, the guide should be used along with the DJ and Drawing.

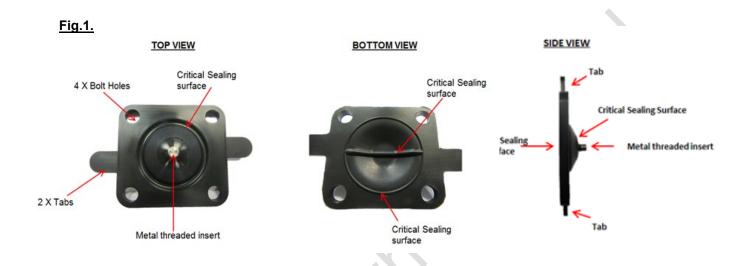
The below photographs show a general view of the Diaphragm and shows the main features of the seal.
