James Walker	Title: POWERMARINE MARINE ALL RUBBER TBMS JOINING AND INSPECTION PROCEDURE	Date: May 22, 2023	Rev: 1	Page: Page 1 of	Document No: SIP 13 Approved by: Quality Team
---------------------	---	----------------------------------	----------------------	-------------------------------	--

General Overview

This document should be referred to as a guide during inspection of any Powermaster Marine all rubber TBMS seal. This procedure should be used in conjunction with any other inspection standard referenced on the DJ and item Drawing.

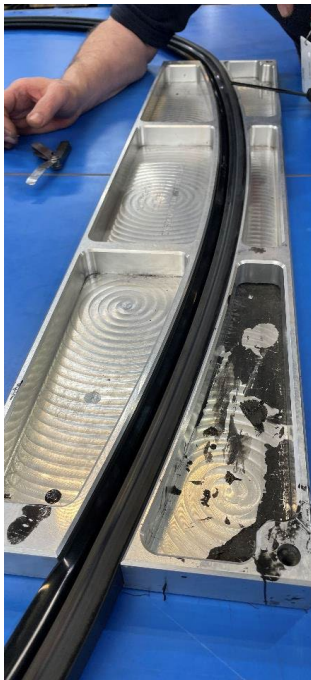
Image 2: TBMS Seal fitted into housing JWC-PD-210070

Seals shall be fitted into a housing, Ref: JWC-PD-210070, Rotthe Erde 3.6M Check Housing with a 32mm section

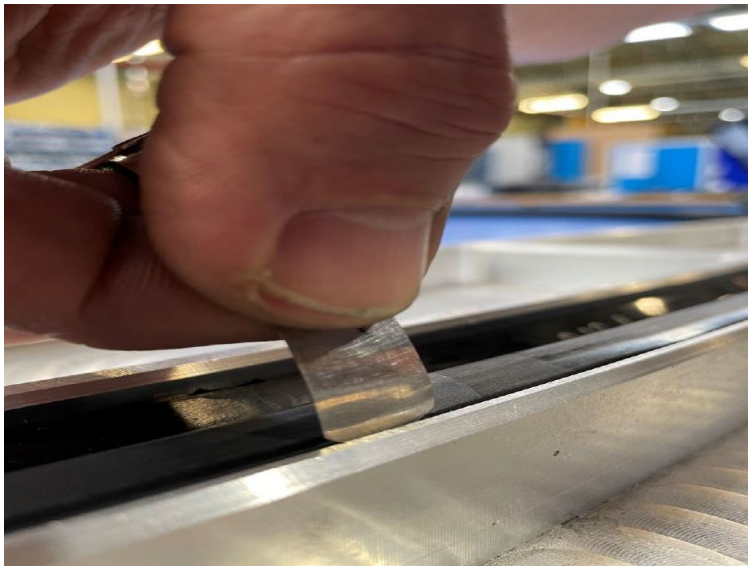
A feeler gauge (0.0015") should be used along the length of the seal in the housing to search for any gaps between the back of the seal and OD of the housing.

Image 3: Examination with feeler gauge

Smallest feeler gauge (0.0015") should not be able to fit between seal back and the housing by more than 1-2mm

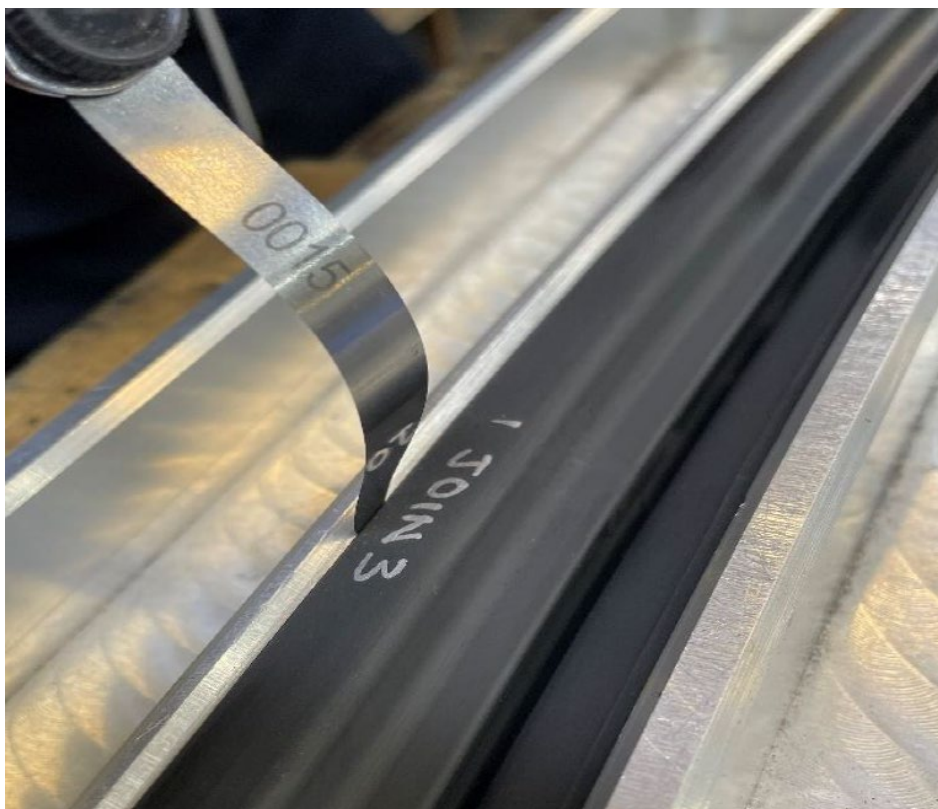
Image 4: Examination of join area with feeler gauge

The seal should be fitted into a 32mm housing and a feeler gauge should be used to inspect for gaps between the seal back and the housing. At no point should the feeler gauge be able to pass between the back of the seal and the housing for more than a couple of mm.

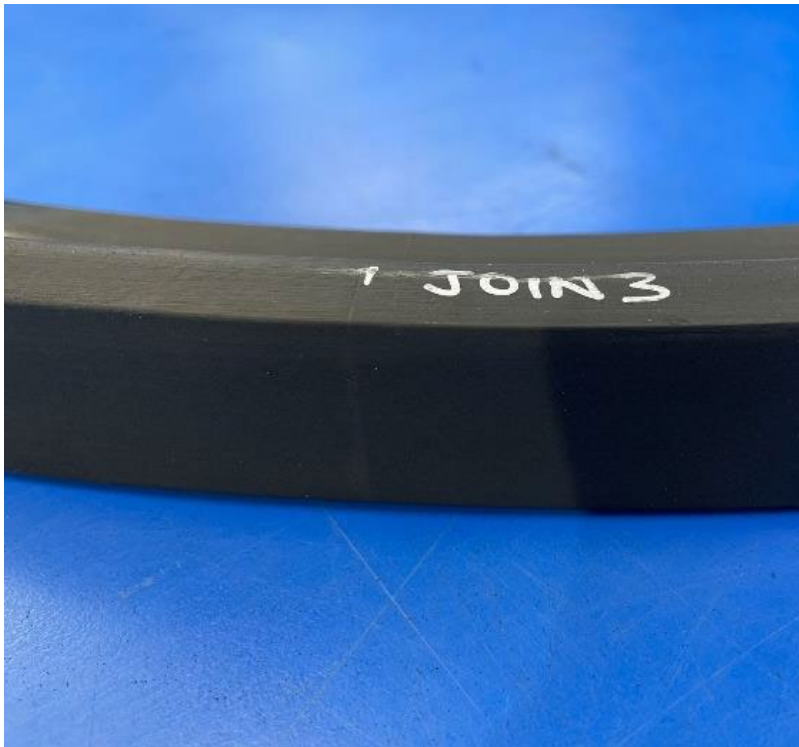
Image 5: Photo of join at seal back

The critical sealing areas are the underside of the seal lip and the seal back (Figure 1) close up photographs should be taken of these areas as demonstrated in Figure 5 and figure 6.

Examples of good joins and the photos that should be taken and recorded with the order

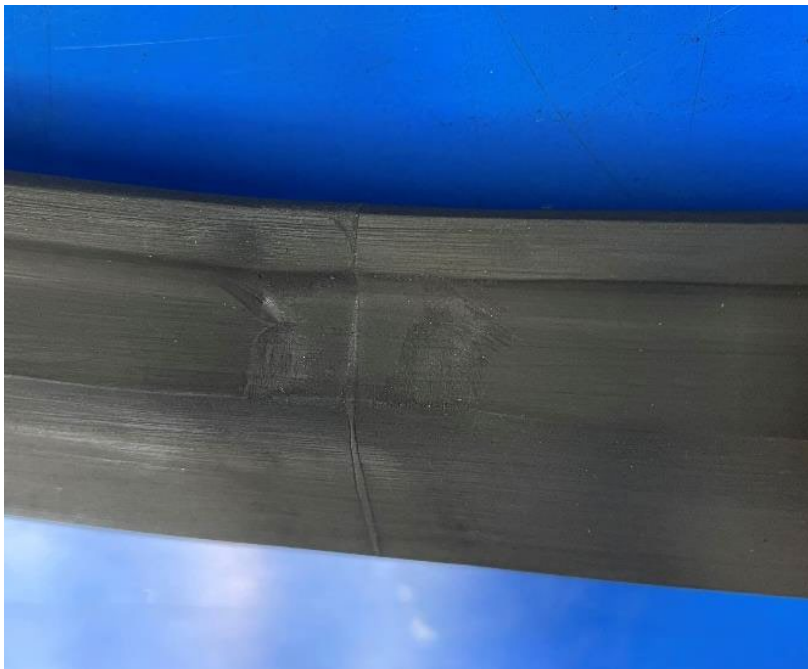
Image 6: Photo of join at seal lip (underside)

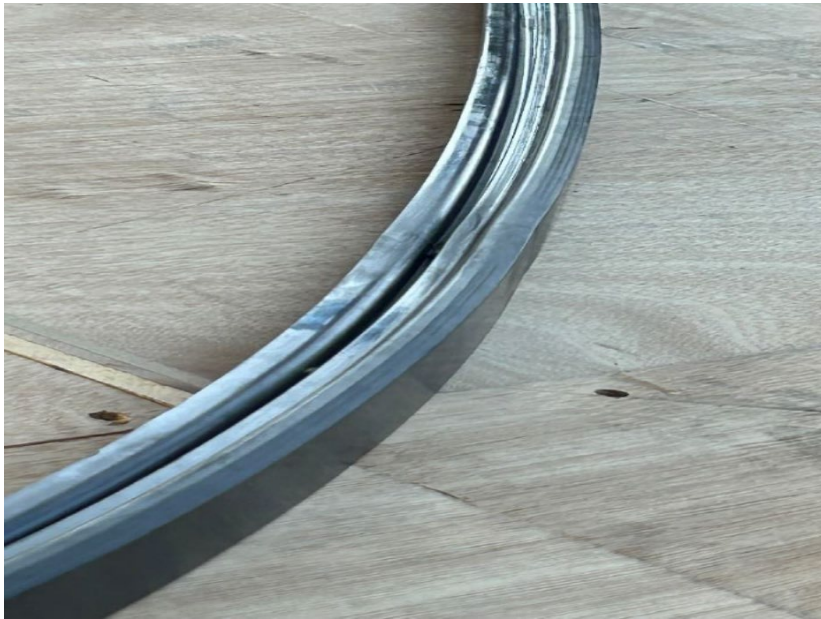
Image 7 Unacceptable join quality, seal in free state

The previously supplied seals had a clear dip in the back and the lip at the join. Photo taken by the customer

Examples of unacceptable join quality both in free state and in housing, Ref: JWC-PD-210070

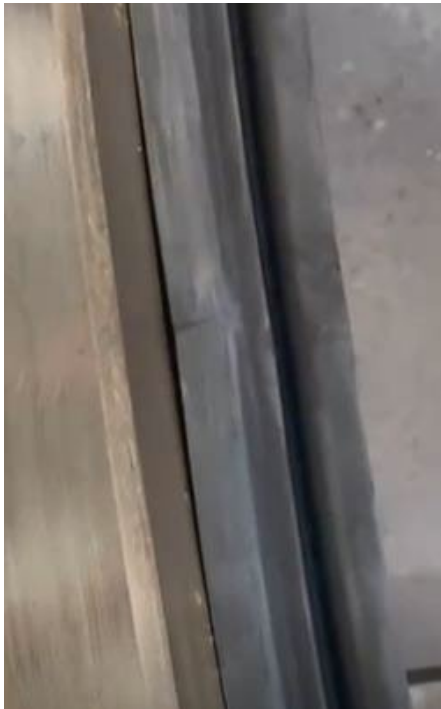
Image 8 Unacceptable join quality, seal fitted in Rothe Erde Housing

When fitted into the housing (without the shaft) the seal back clearly pulled away from the housing. This gap was reduced when the shaft was fitted, however a leak was still found in these locations.
