SIP18 – JAMES WALKER INTERNAL INSPECTION STANDARD FOR GLASS BACK (X-GEN) D6 & D7 WALKERSELES.

QUALITY STANDARD

Please use this standard for inspecting an X-Gen D6 or D7 seal.

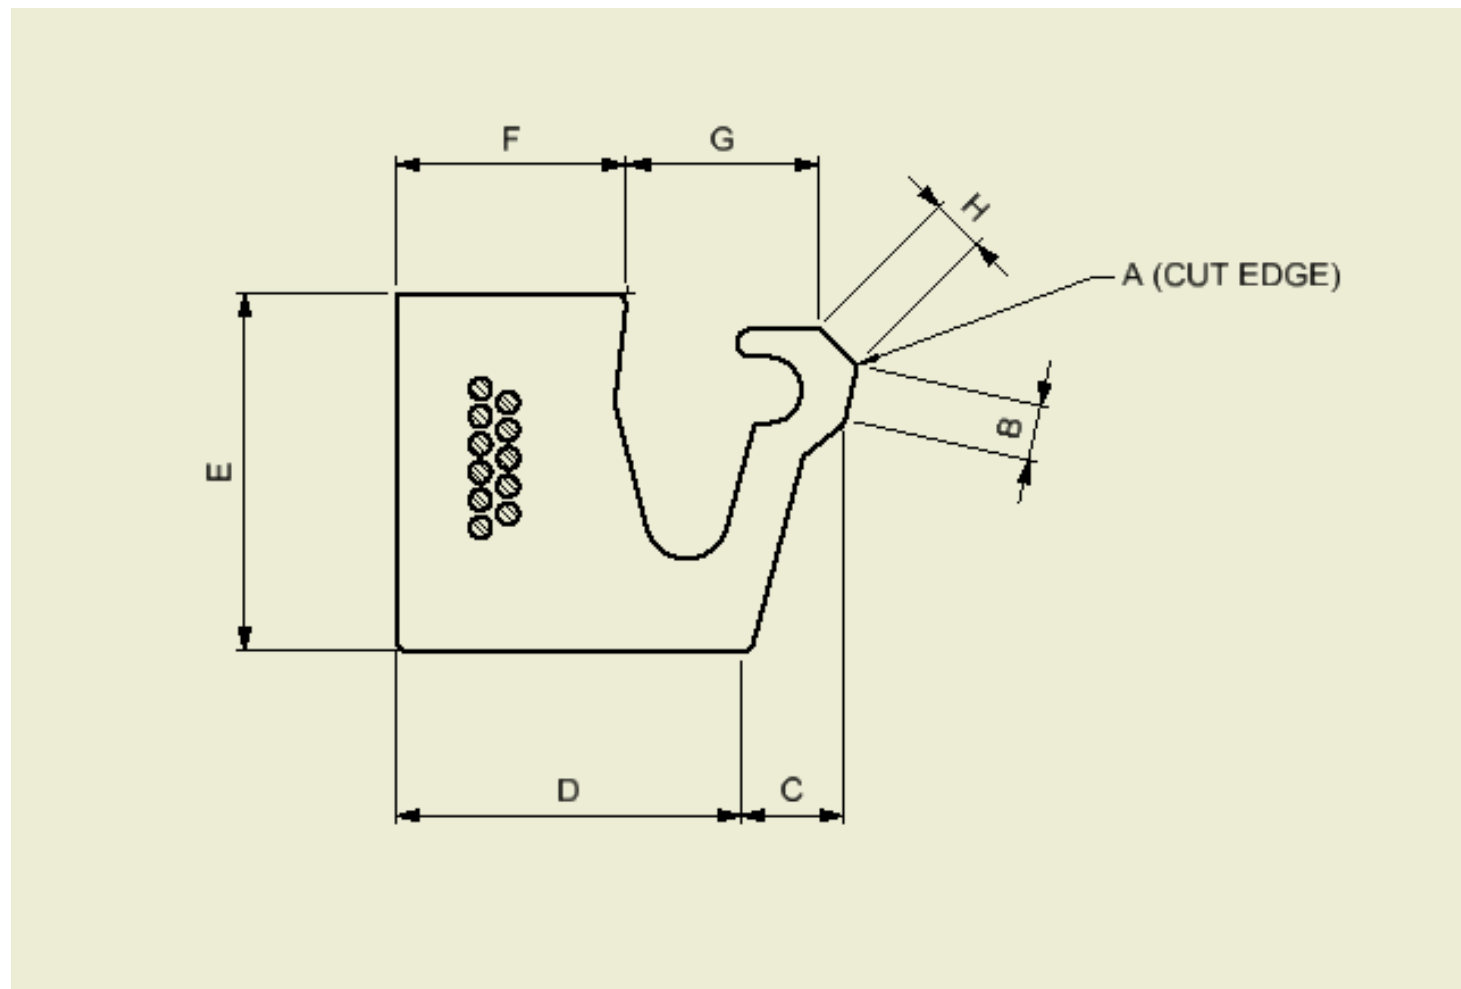
The diagram shows a general view of the seal and its main features.

Zone A: Sealing edge - **HIGHLY CRITICAL**

Zone B: Outer running face - **HIGHLY CRITICAL**

Zone C: Non-critical

Zone D: Static sealing face - **CRITICAL**

Zone E: Static sealing face - **CRITICAL**

Zone F: Static sealing face - **CRITICAL**

Zone G: Non-critical

Zone H: Inner running faces - **HIGHLY CRITICAL**

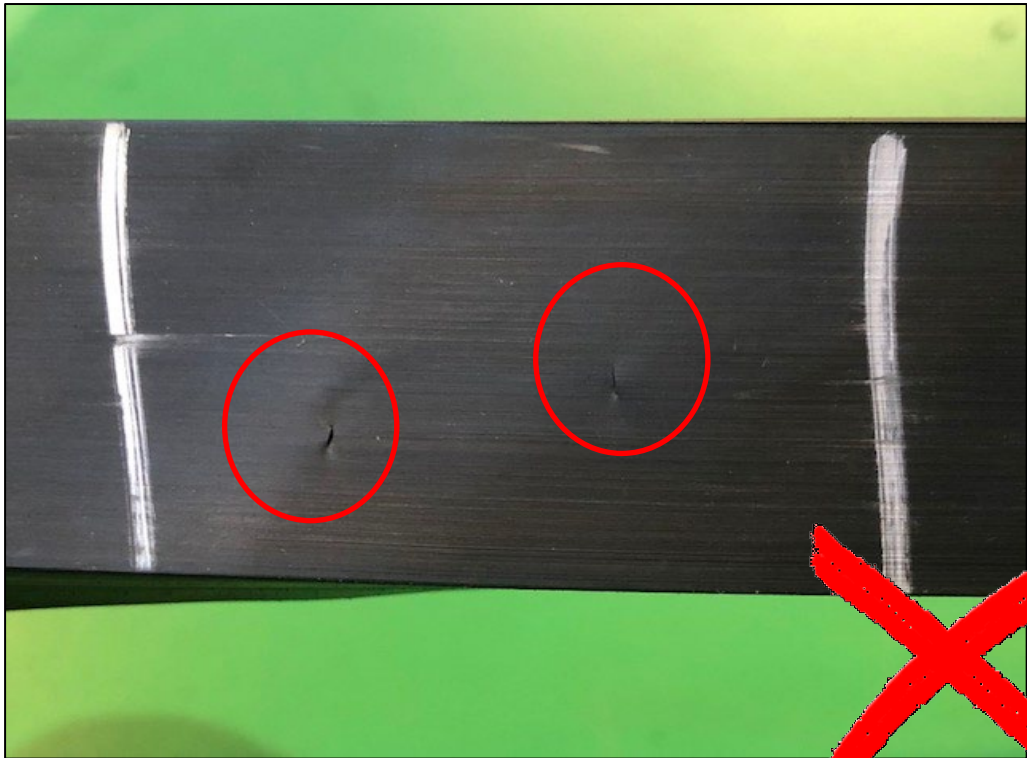
Air Trap, split

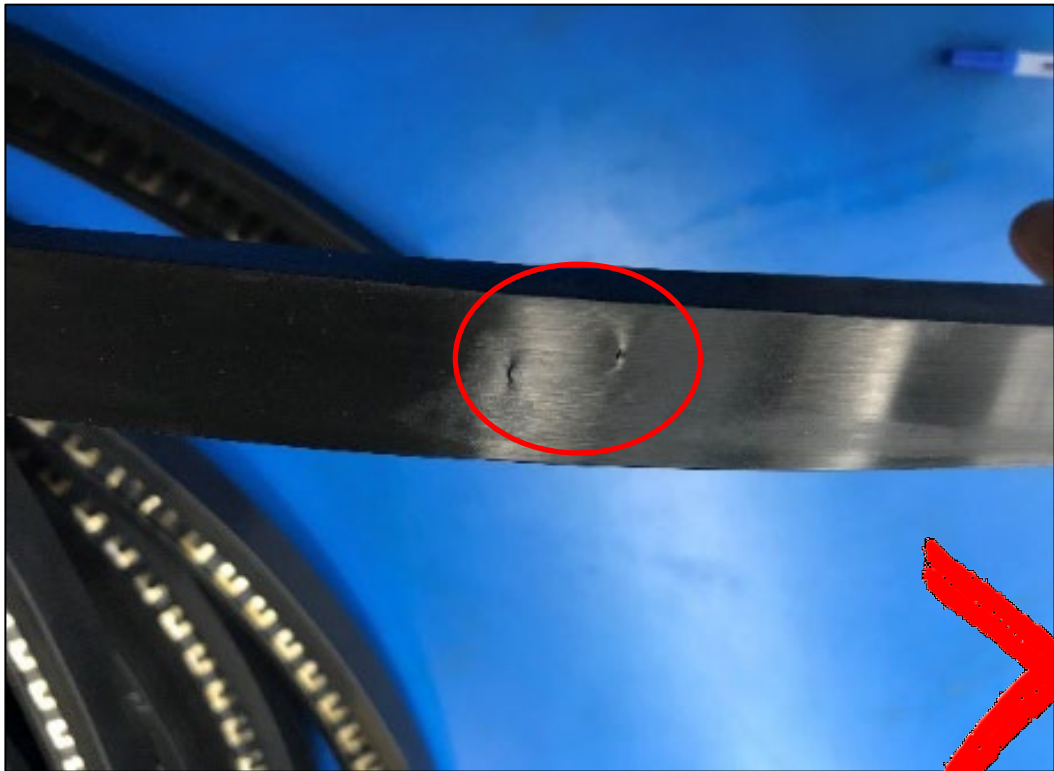
Air Trap, split

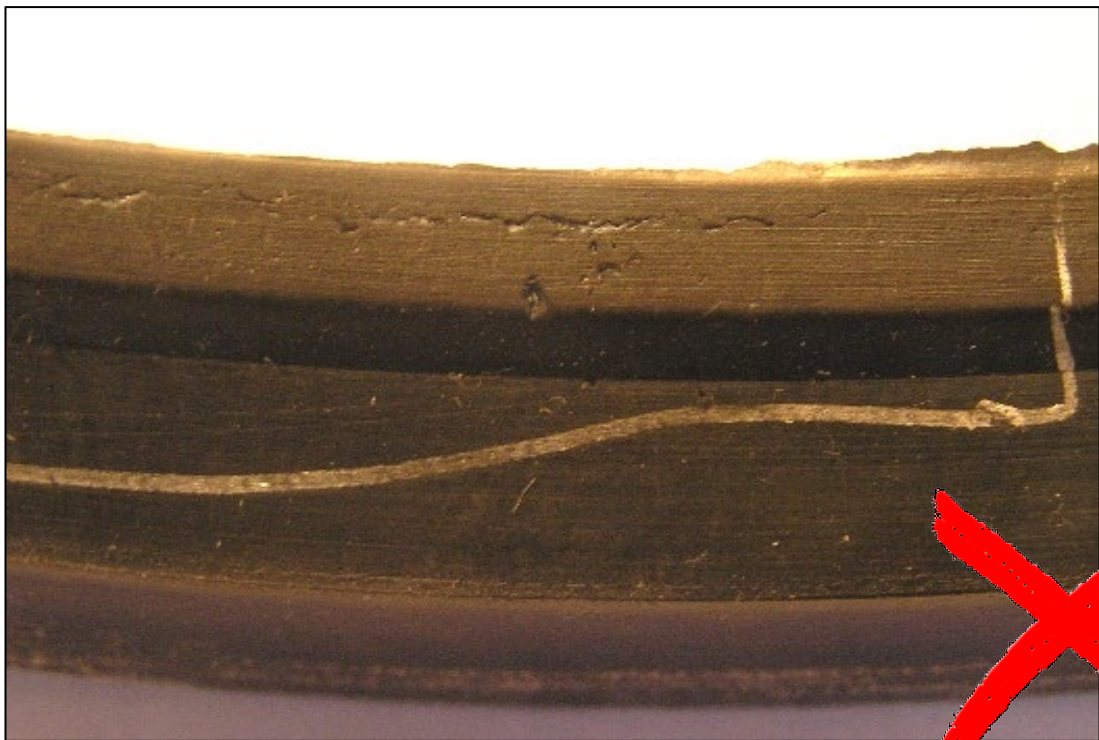
No fill

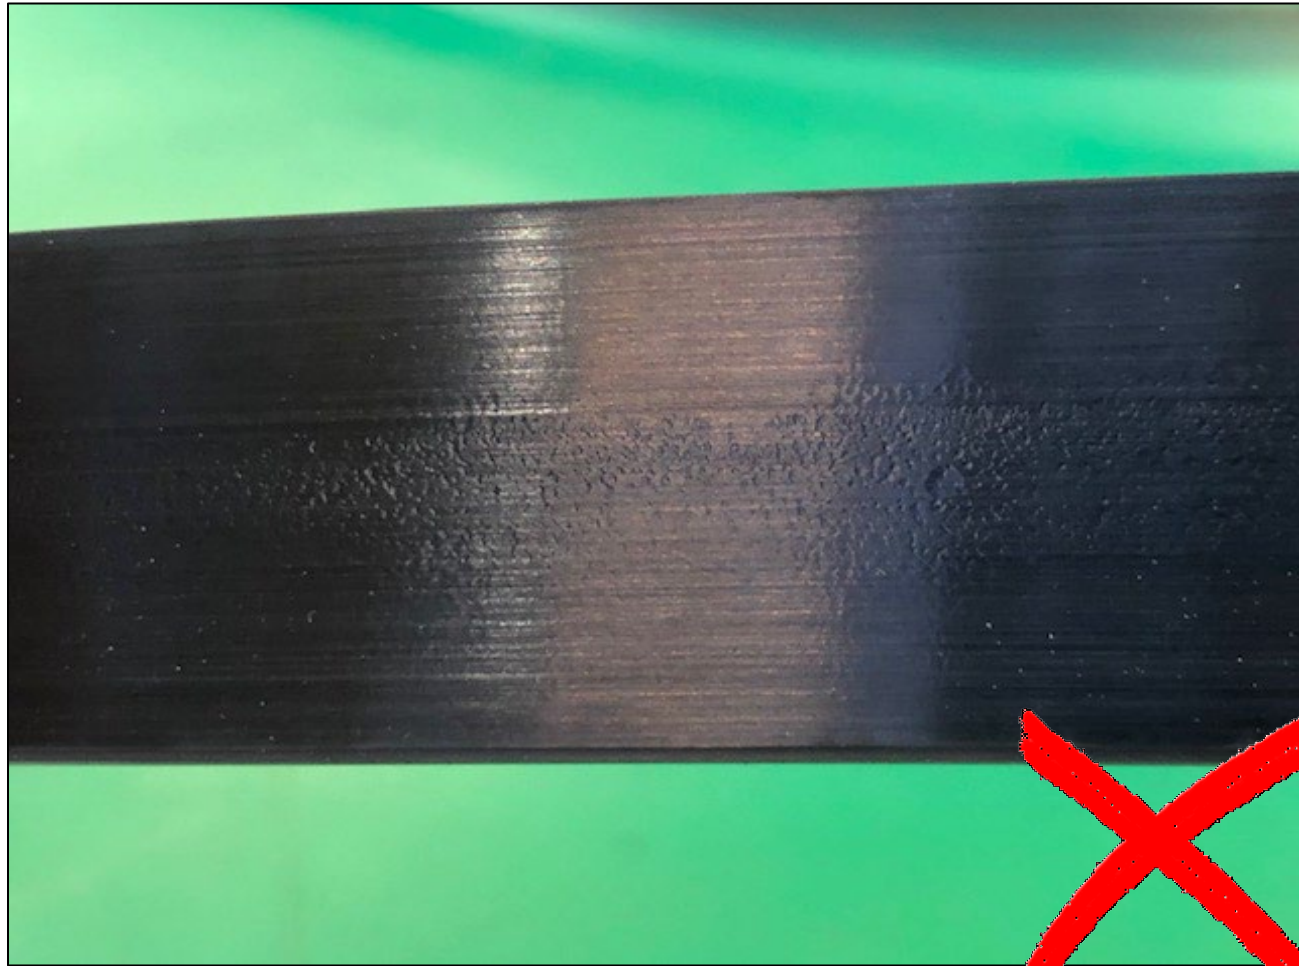
Major scorching

Major scorching causes irregularities in the surface smoothness and is a defect. This is more evident in the tactile check.

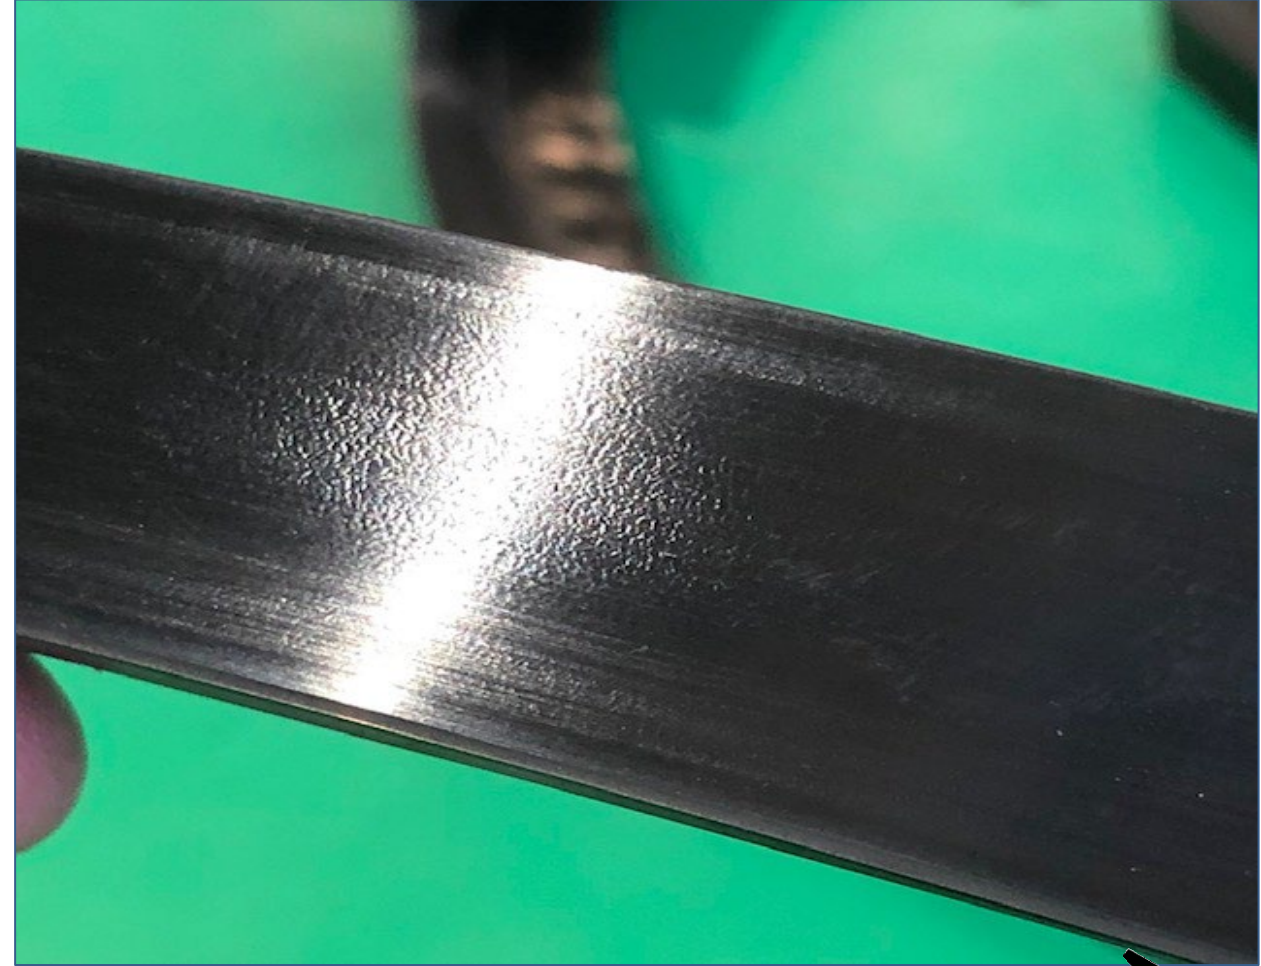
Minor scorching

Minor scorching is acceptable and is defined as scorching that doesn't affect the smoothness of the surface finish.

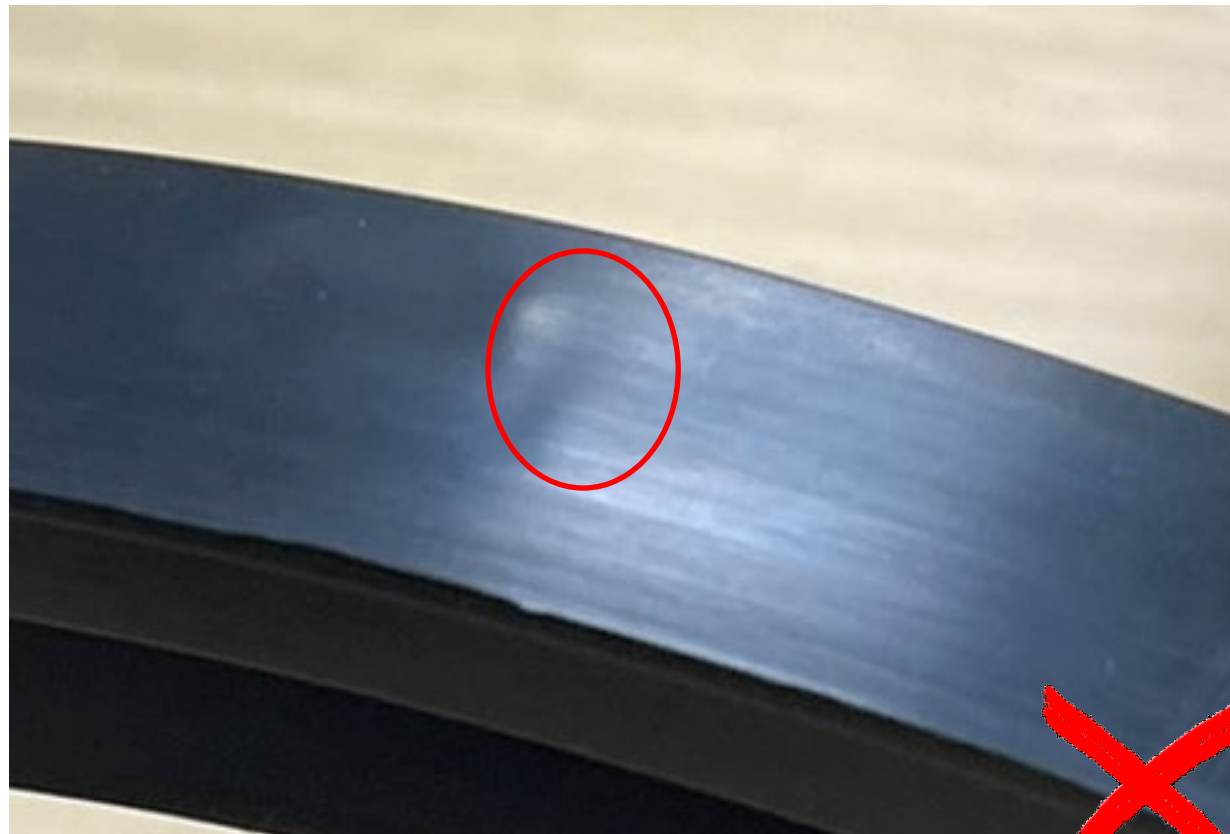
Bump away from join

Small bumps on the outer diameter of the join are allowed, any bumps elsewhere should be rejected.

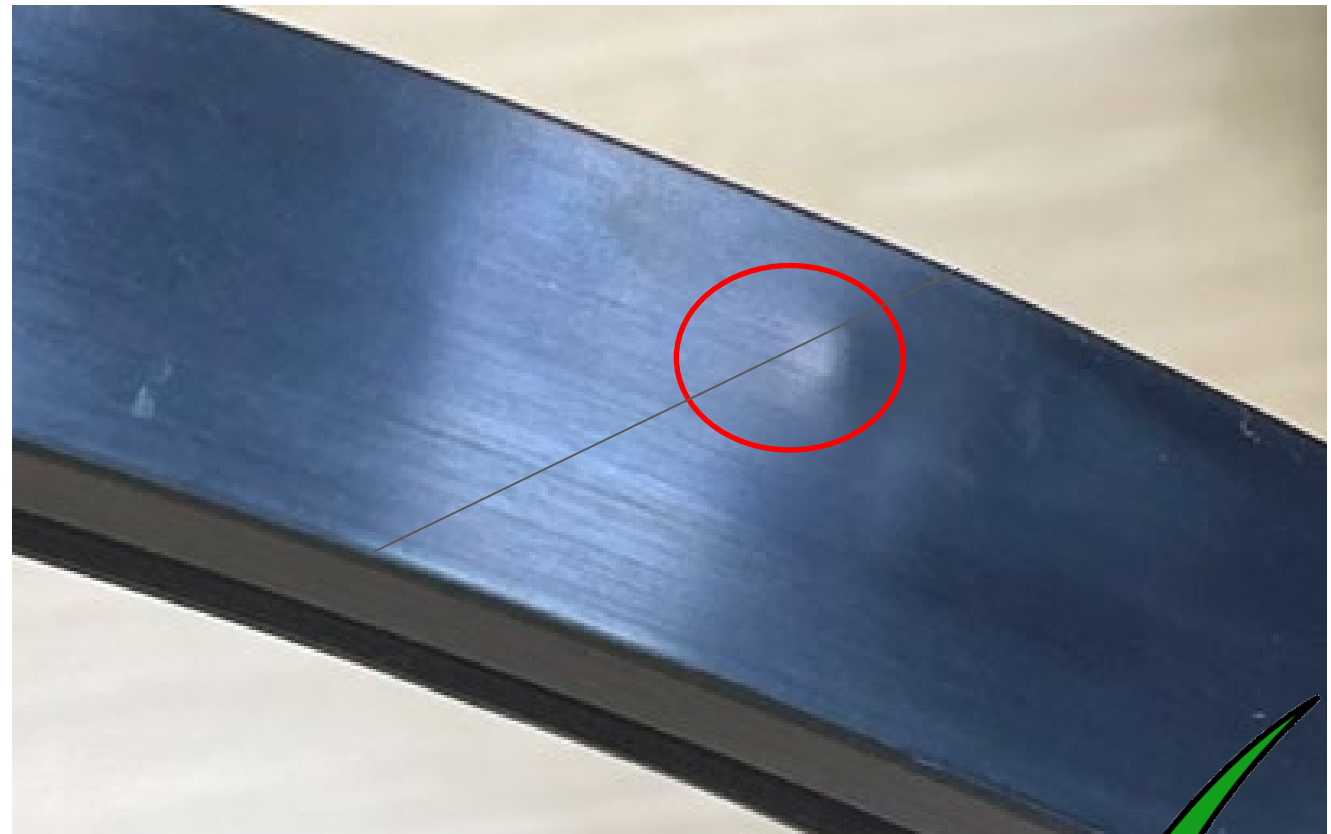
Bump at join

Due to the nature of loading the mould with glass cord centred extrusion displacement of the cords can occur during the moulding process. This can result in bumps appearing where the two lengths of extrusion are joined.

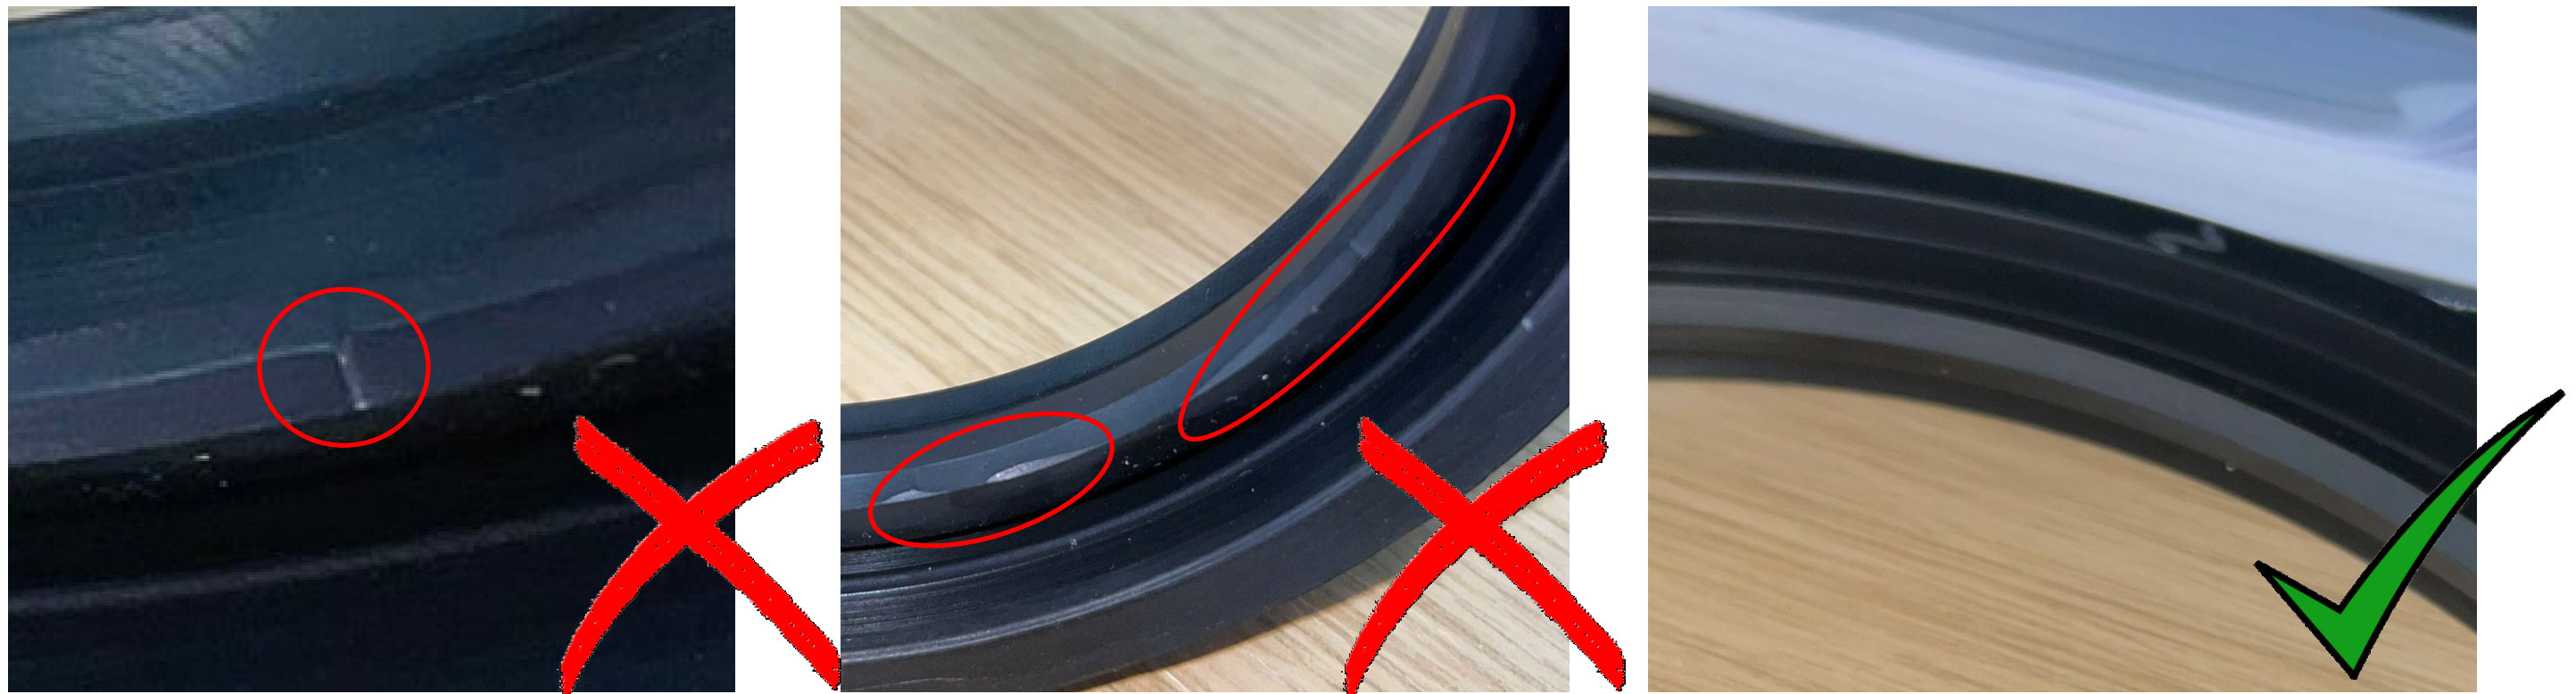
Chamfer should be clean cut with sharp edges. There should be no change in visual aspect of the chamfer.

Check for holes and splits in the chamfer especially at the join area. A split or hole is a reject as this indicates damage to the join.

Slight dips may be felt at the join area which is different to a hole or a split. A dip of less than 0.2mm is acceptable, provided overall section is maintained and tolerances are met?

When dressing the join around the chamfer, take care to preserve the clean cut sharp edges as this is the critical zone of the seal. A rounded edge on the lip chamfer is a reject.

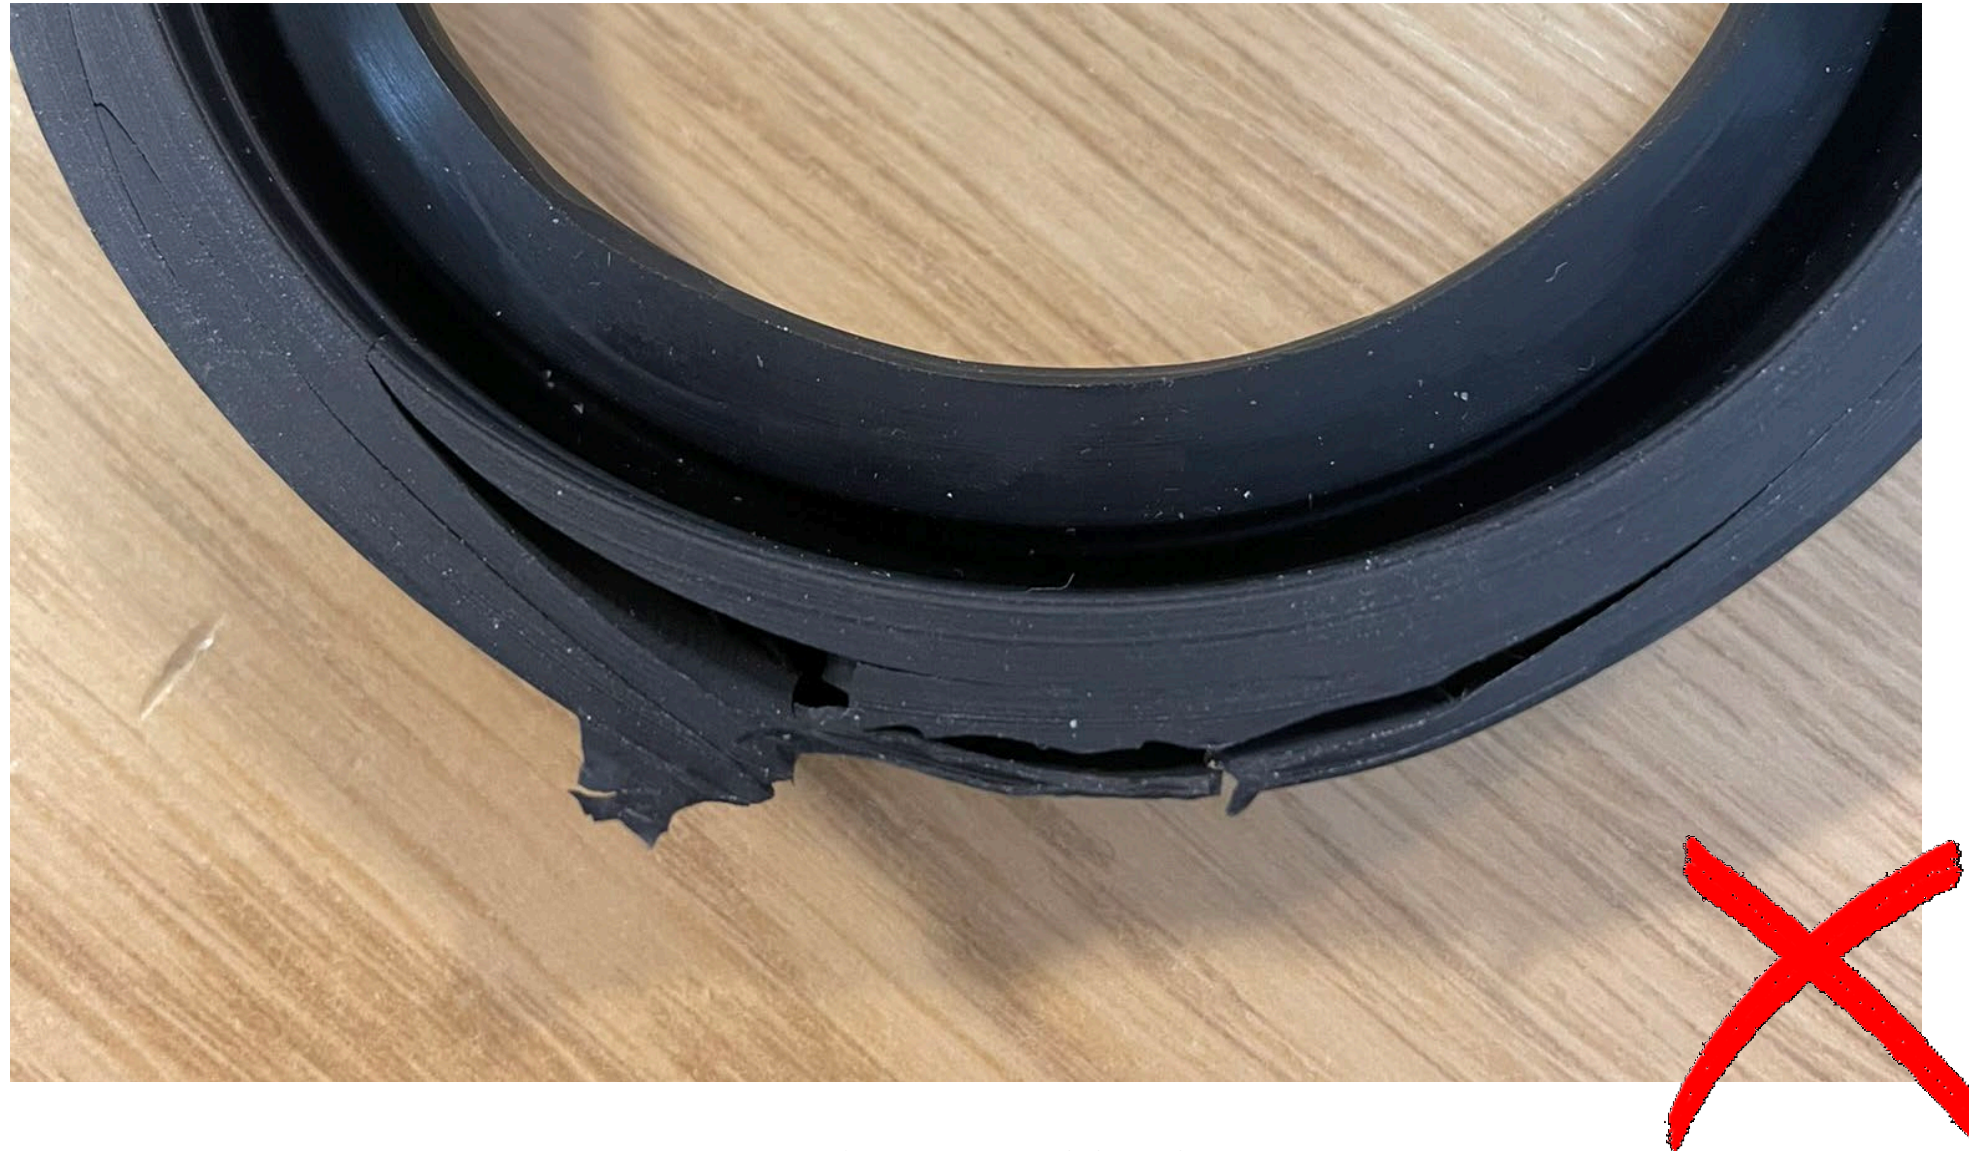
Tearing at seal back

Any tearing across any part of the seal should be rejected to prevent faulty seals being put into operation.

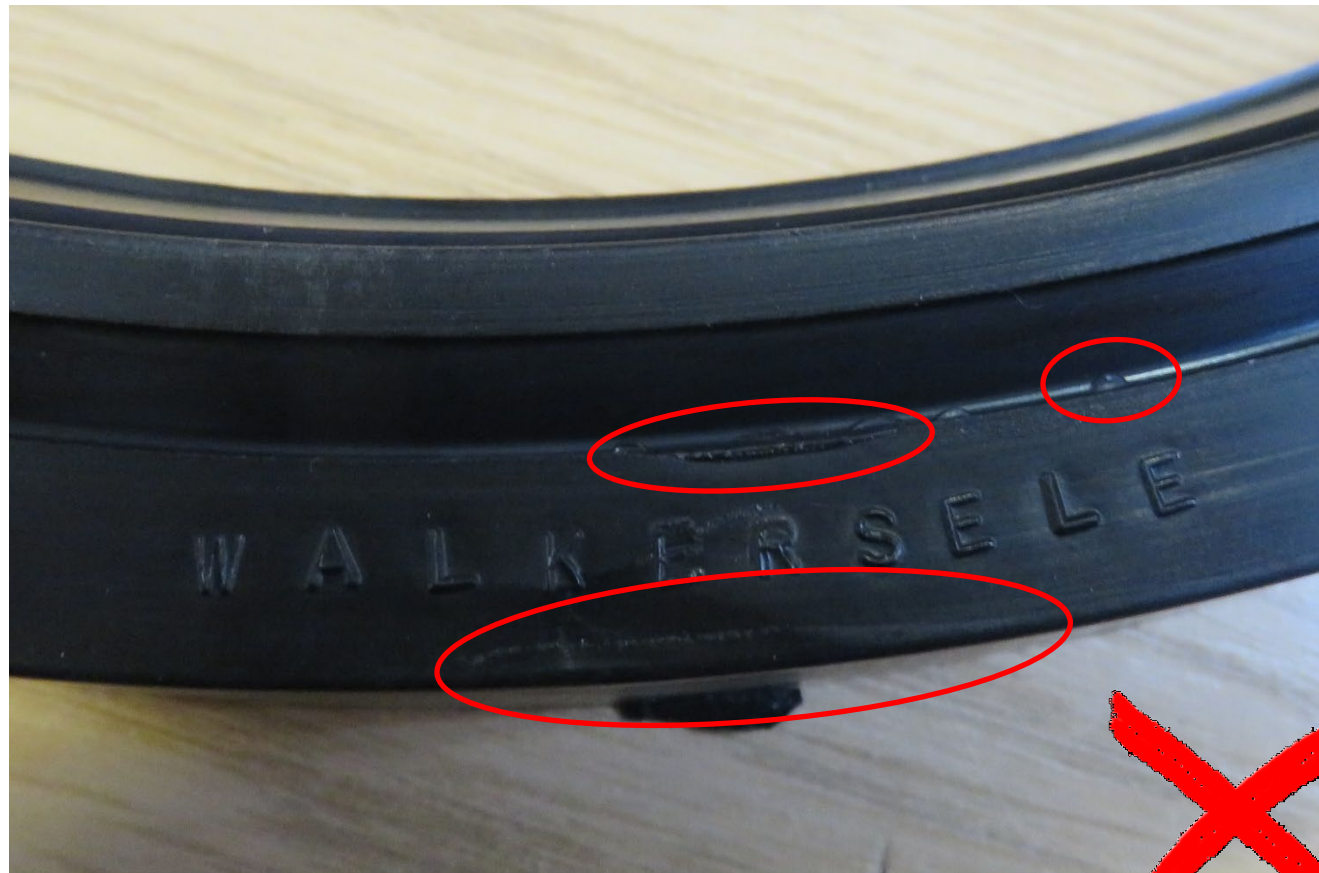
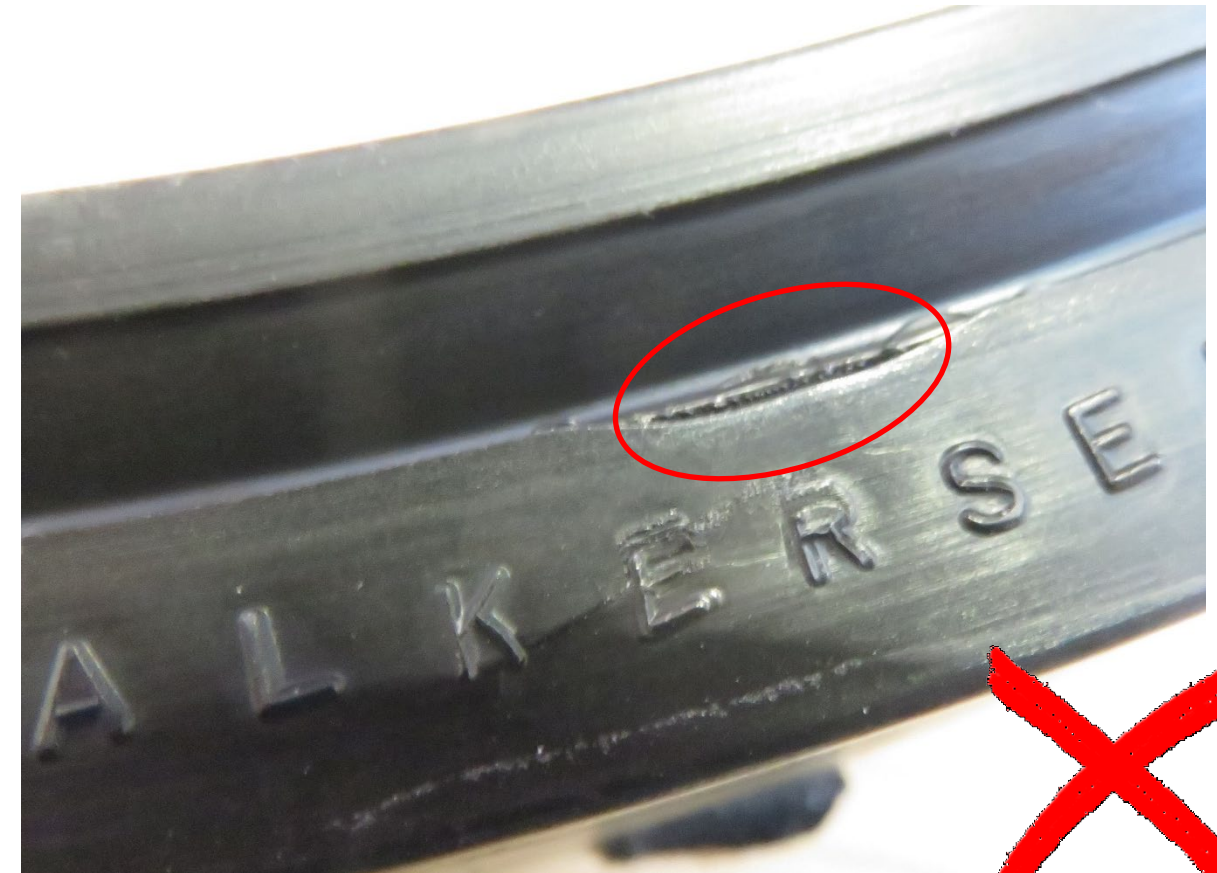
If there are any deformations along seal that are noticeable to the naked eye then reject the seals to maintain a high quality perception of our products.

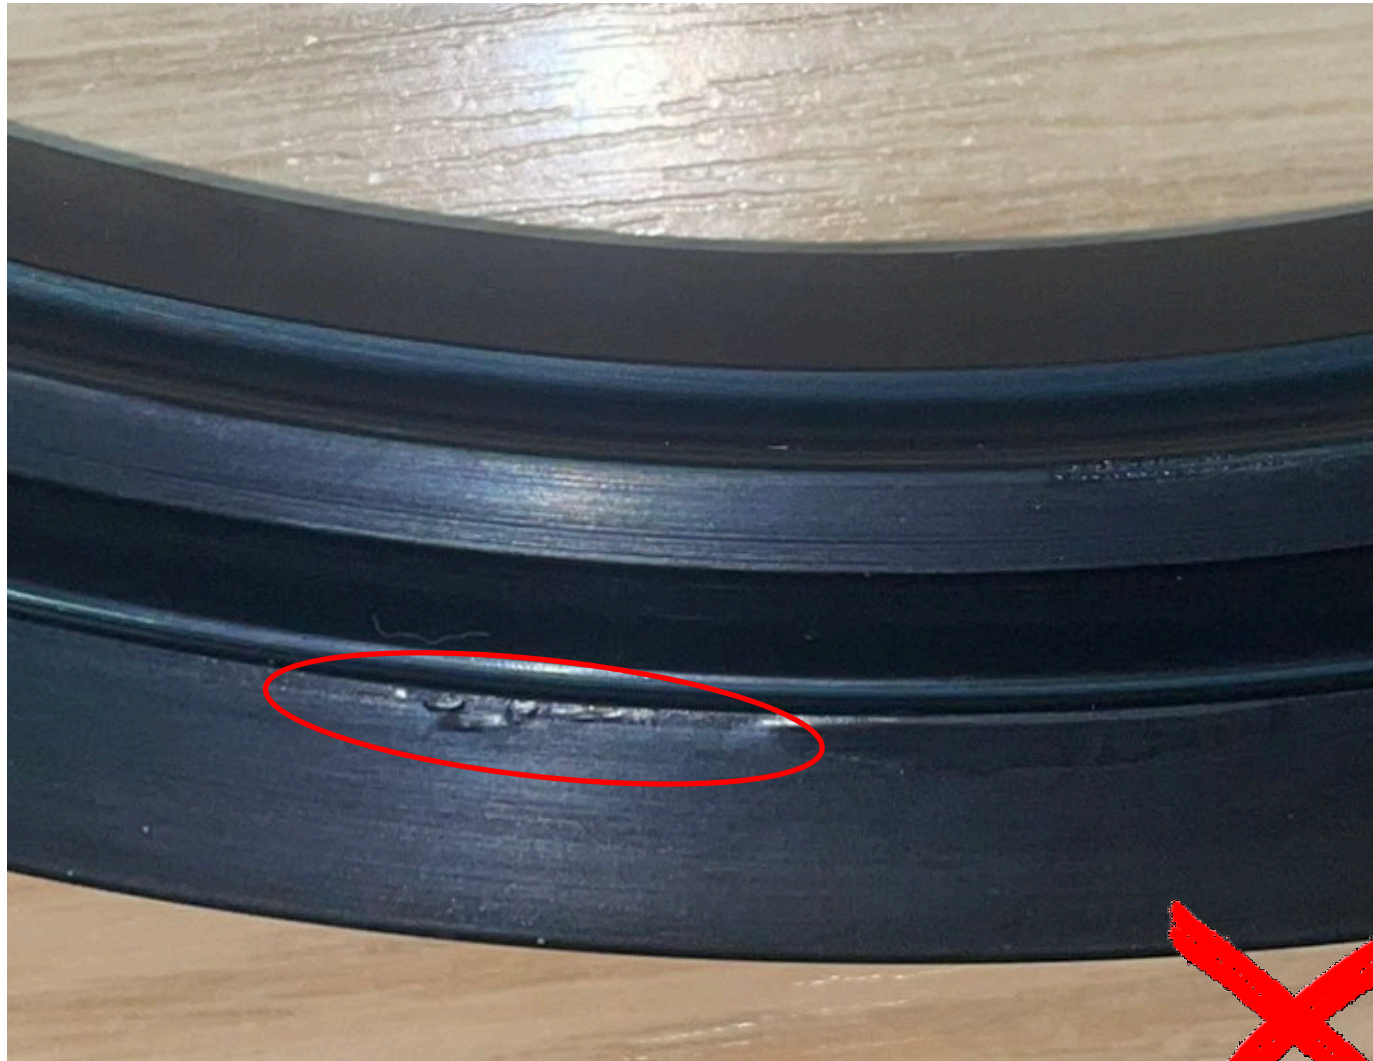
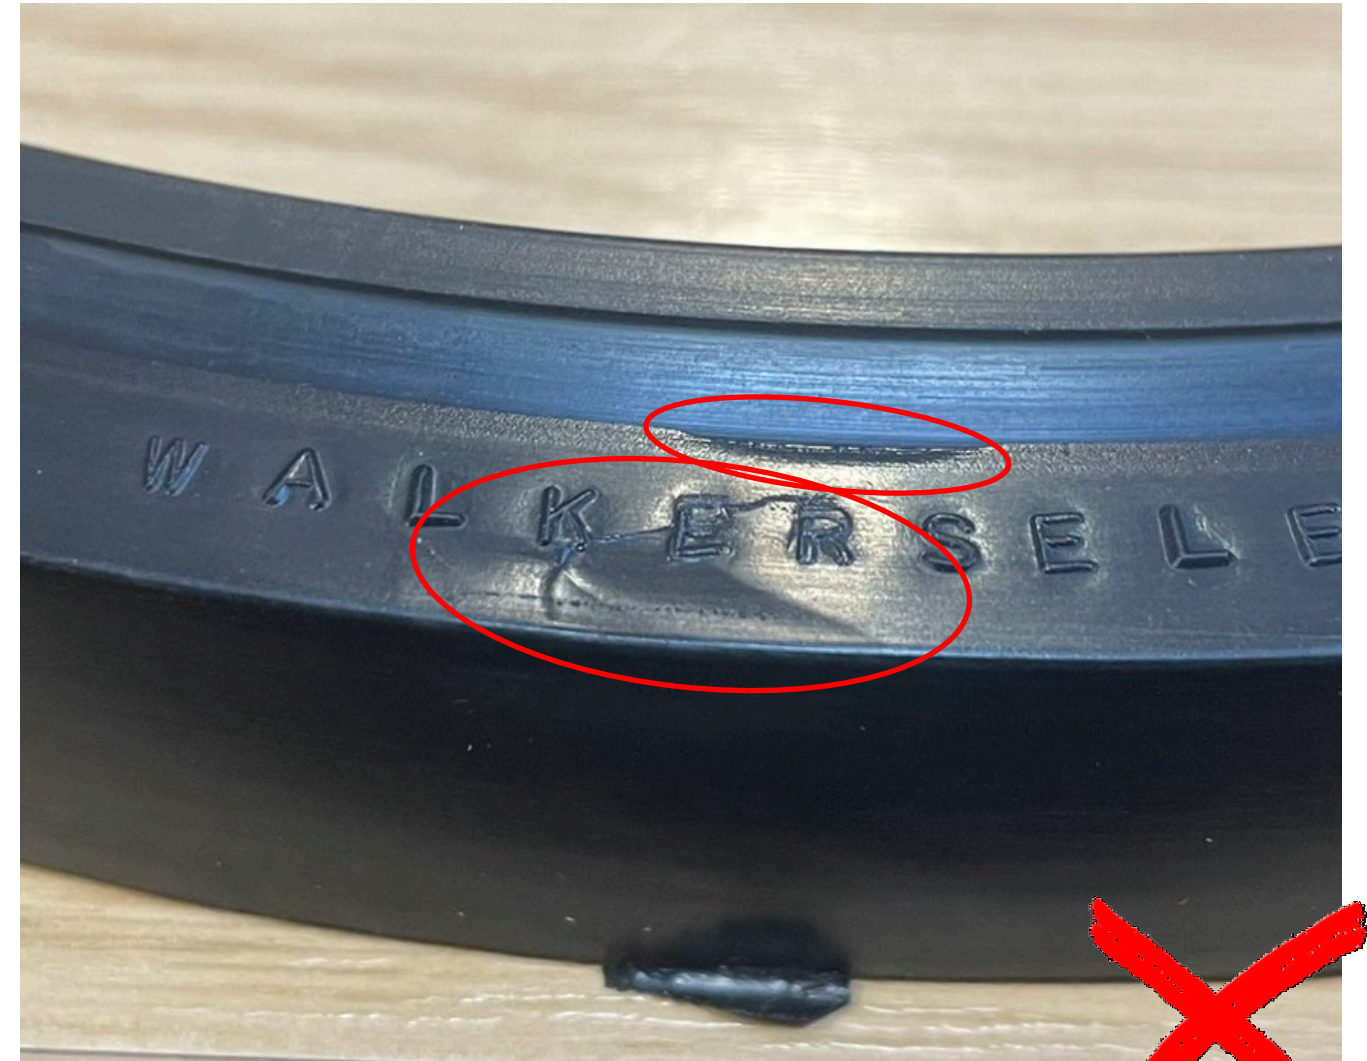
If there are any deformations along seal that are noticeable to the naked eye then reject the seals to maintain a high quality perception of our products.

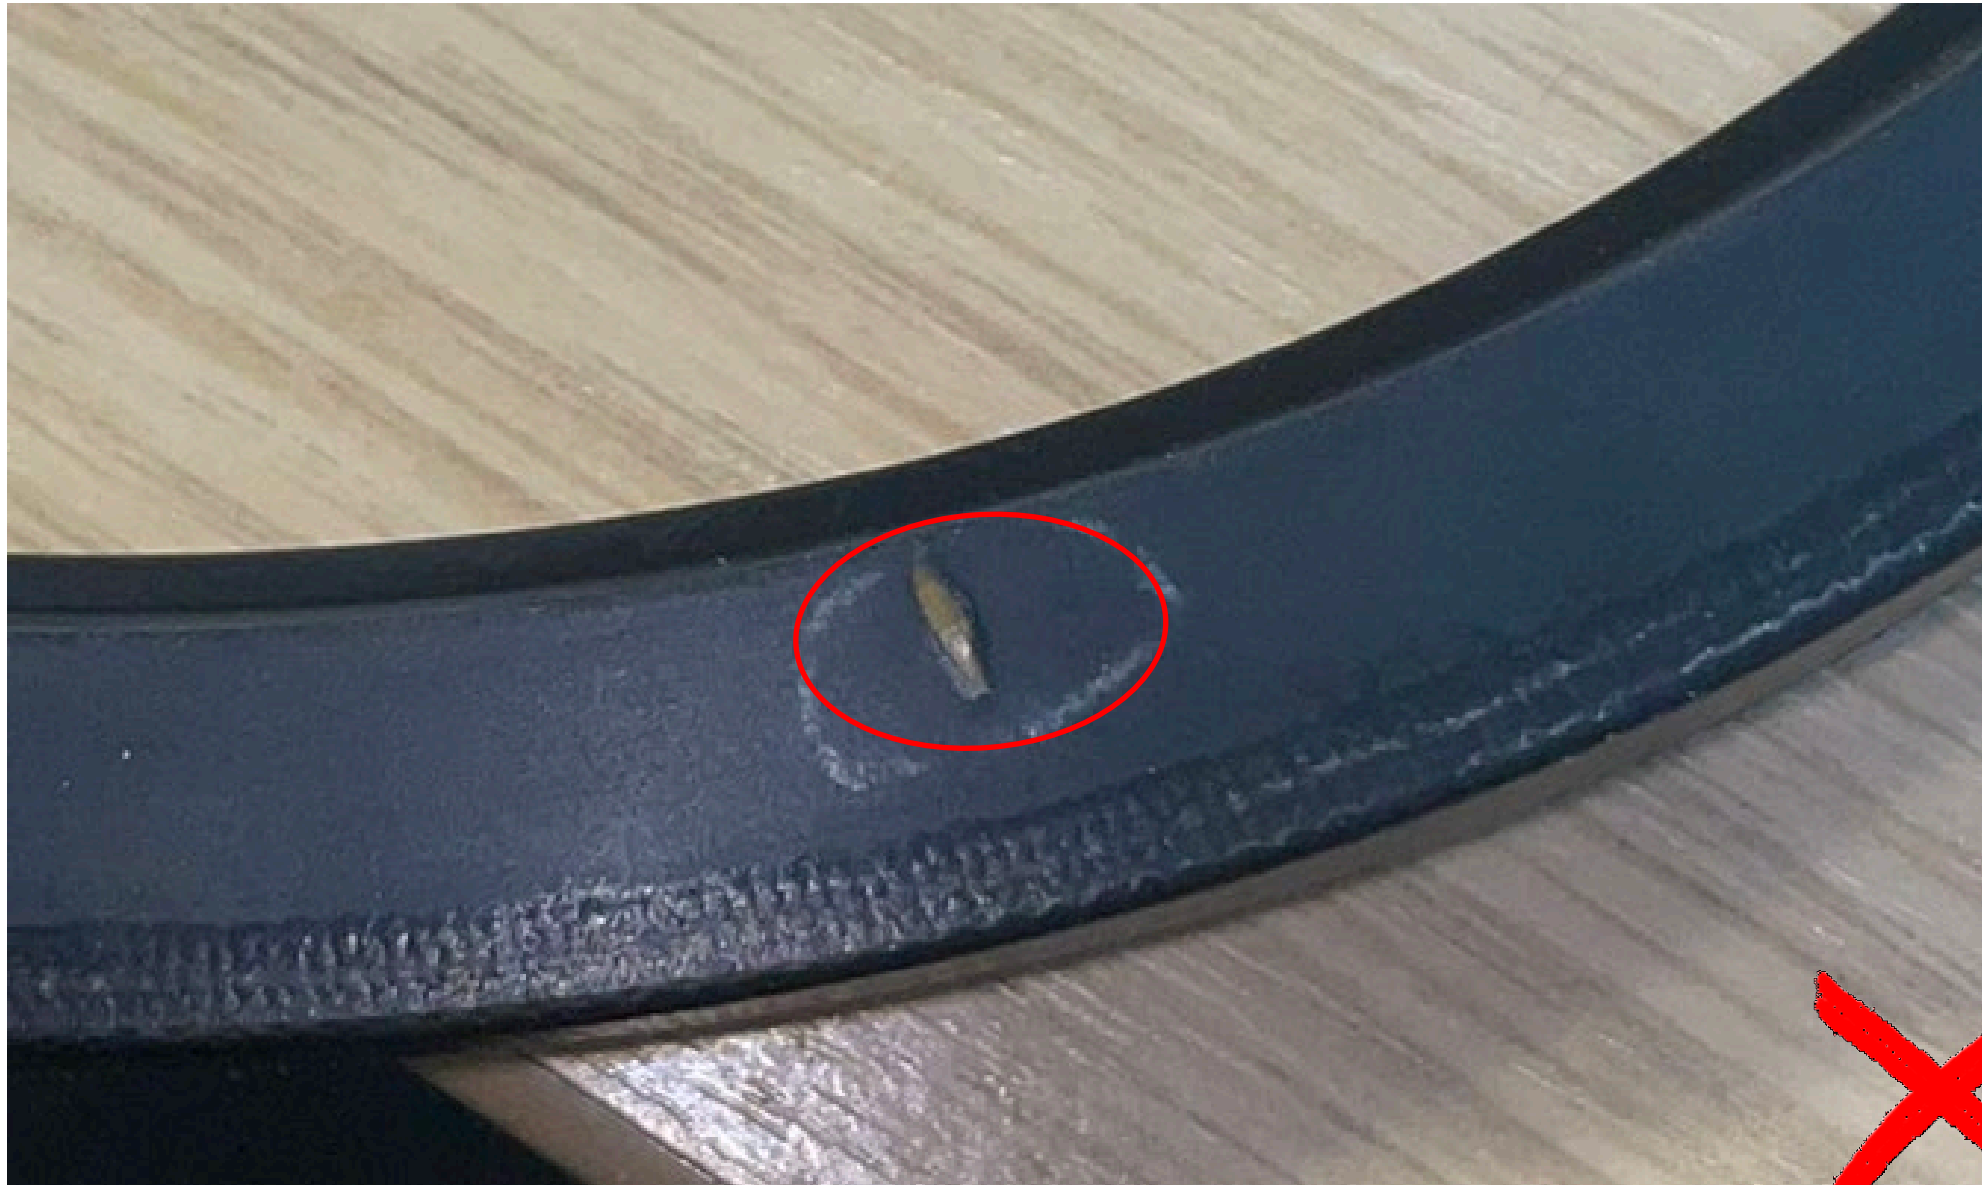
Inclusions refer to any foreign material or substance that is unintentionally incorporated into the rubber during the moulding process. This could be anything from dust or dirt particles, to fragments of metal or other materials from the manufacturing environment. Any inclusion should be rejected.

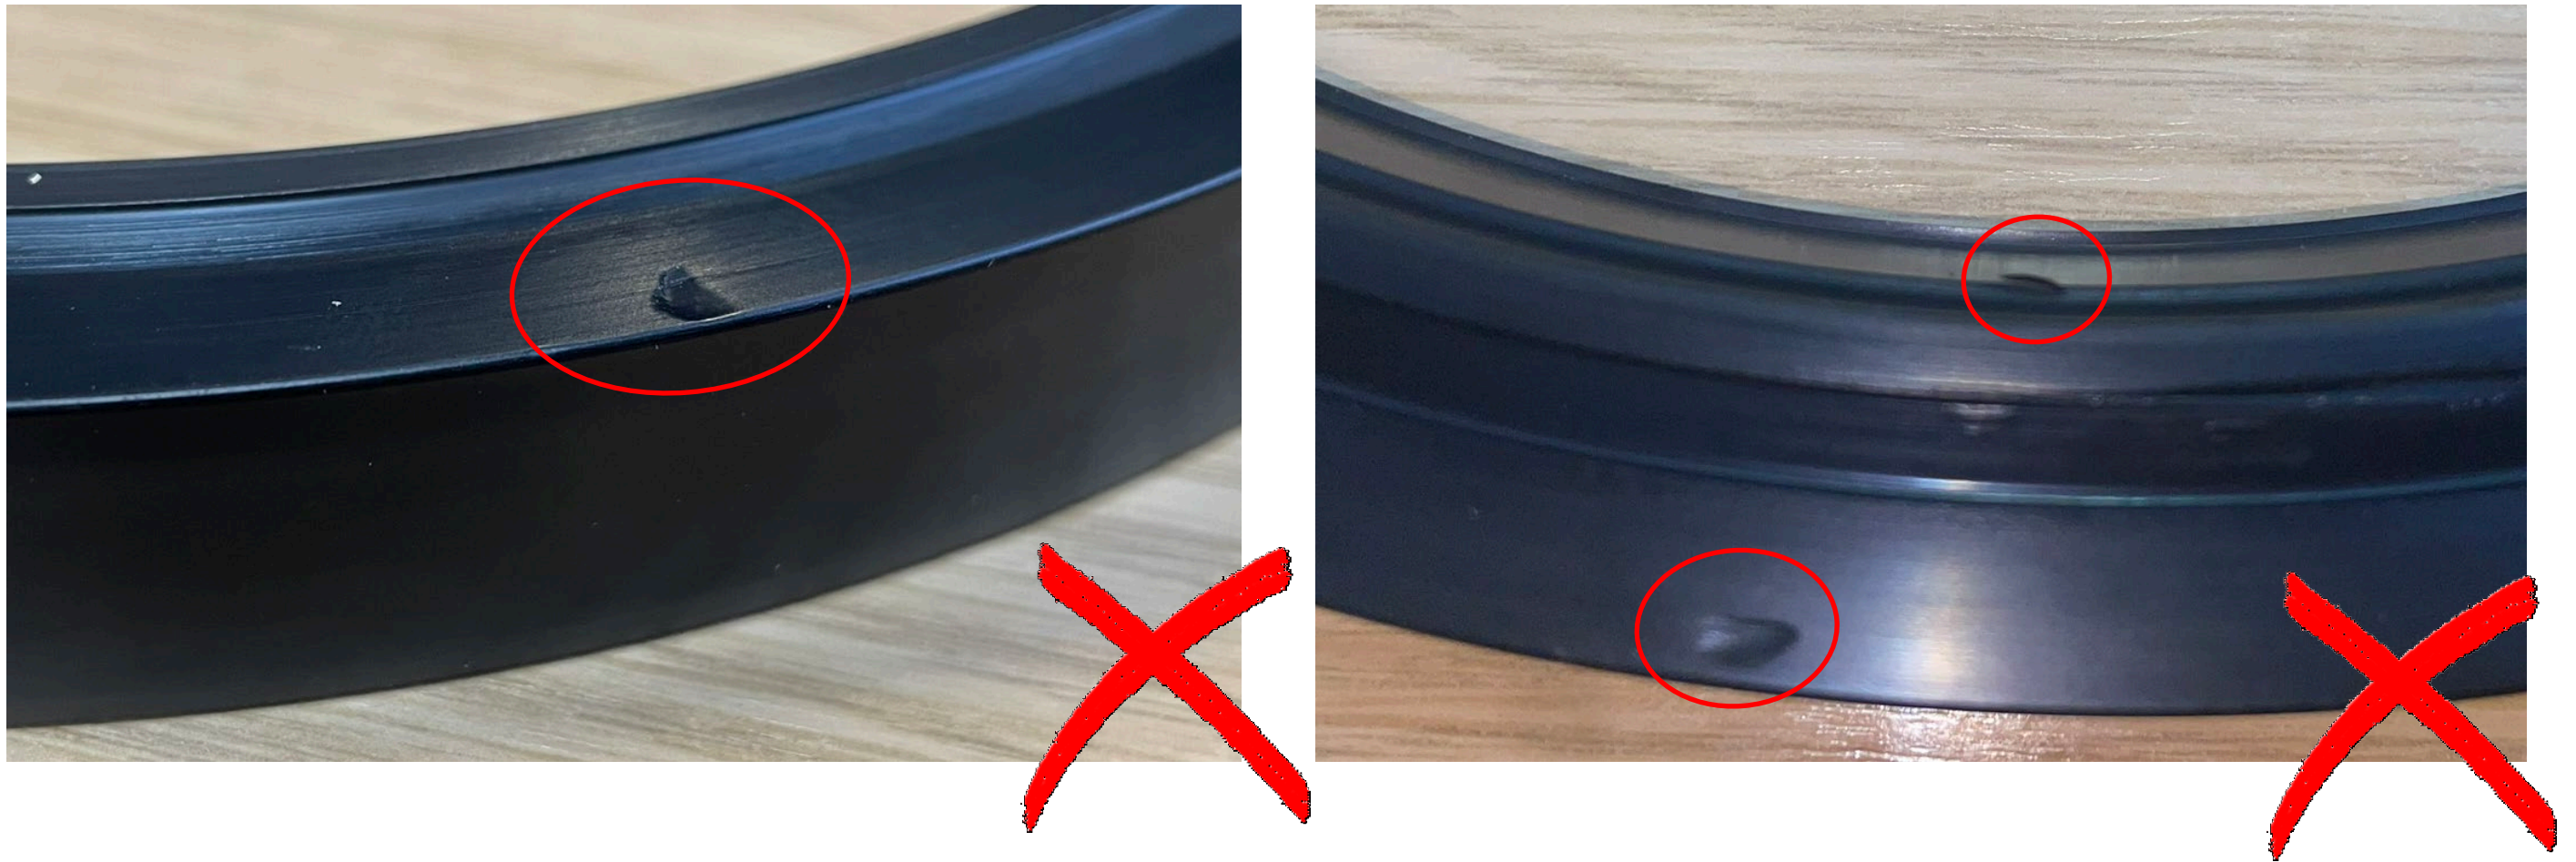
Any air trapping that can be seen with the naked eye should lead to the seal being rejected.
