SIP18 – JAMES WALKER INTERNAL INSPECTION STANDARD FOR GLASS BACK (X-GEN) D6 & D7 WALKERSELES.

QUALITY STANDARD

Please use this standard for inspecting an X-Gen D6 or D7 seal.

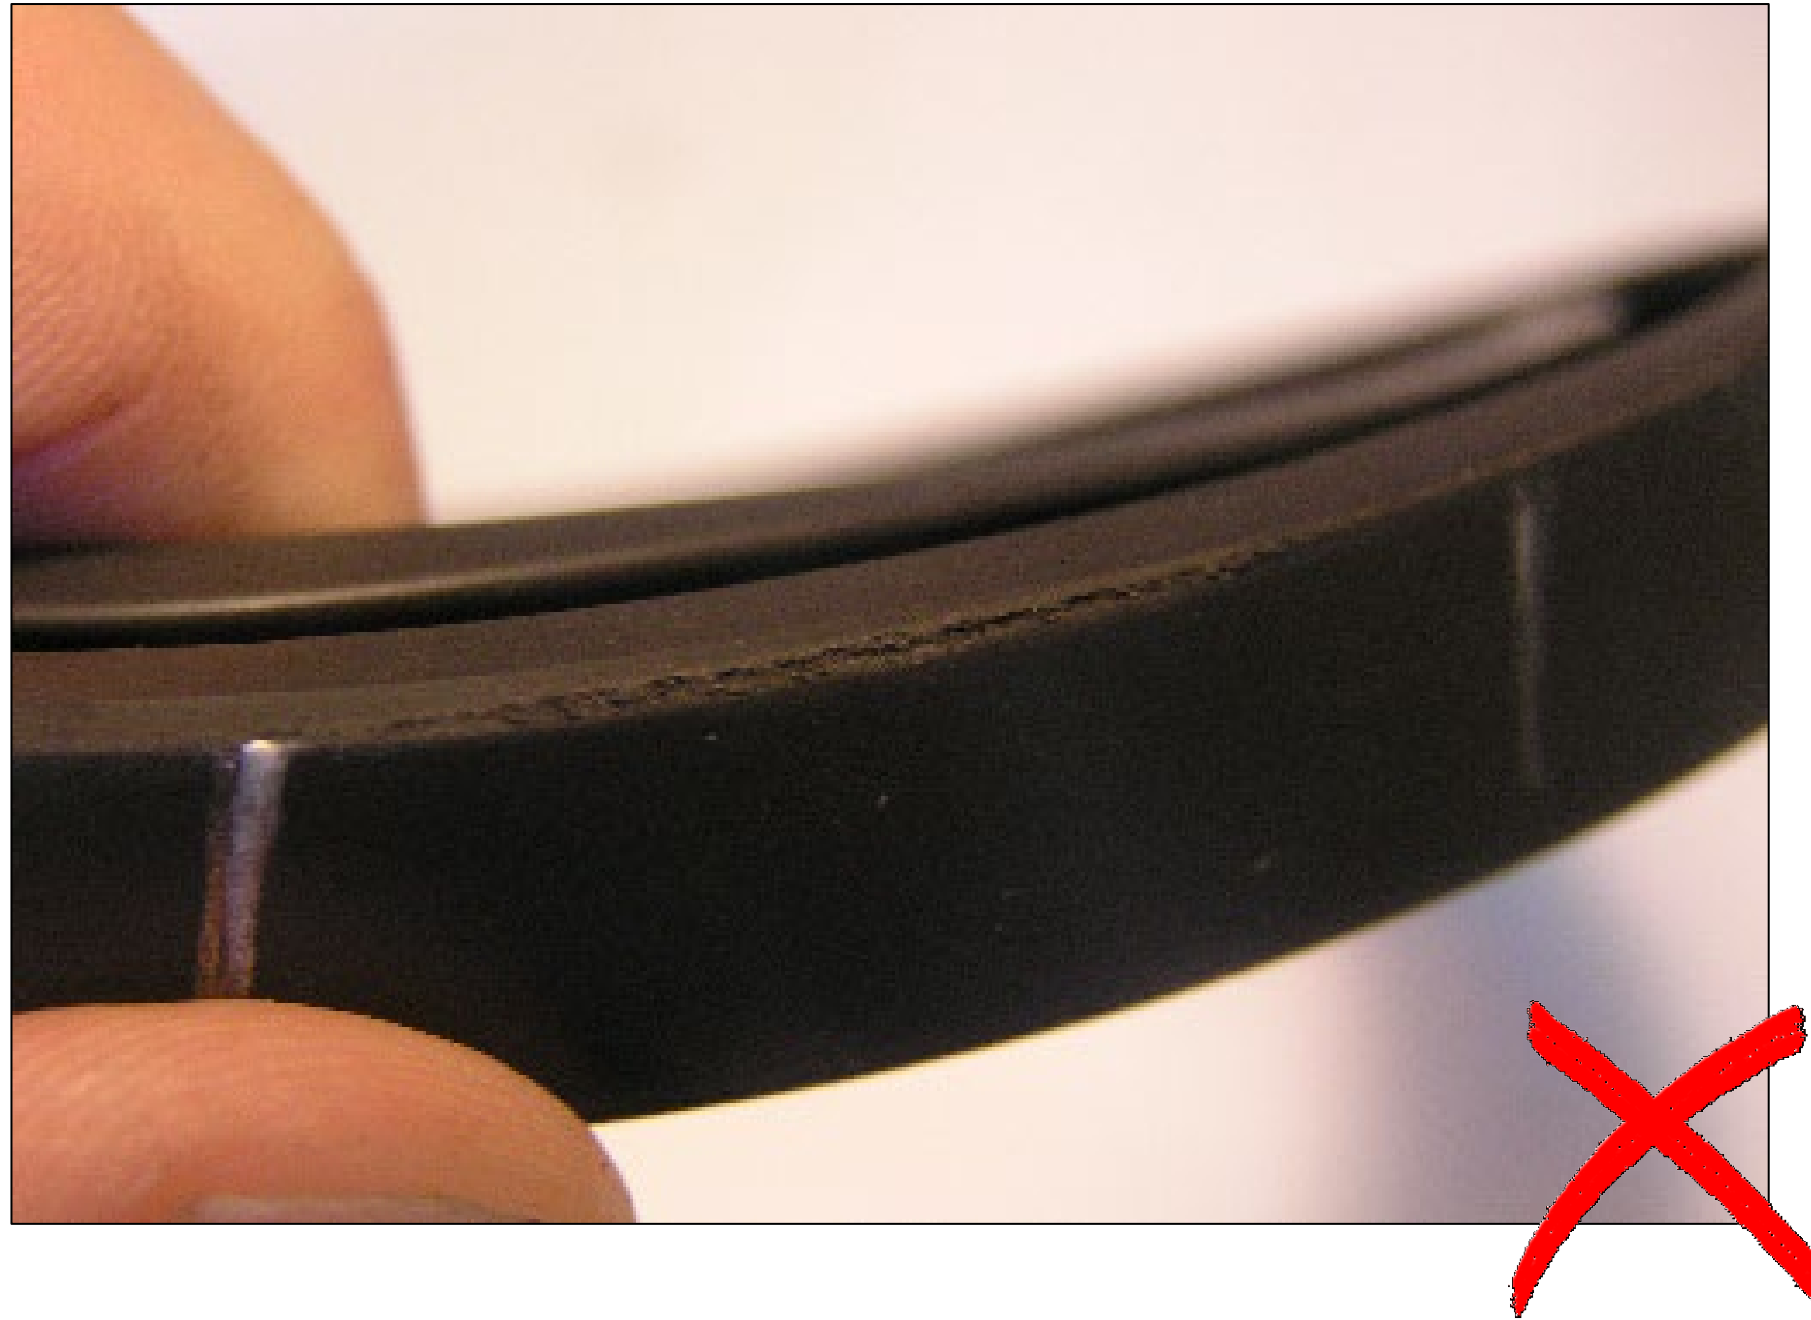
Backrind appears as a torn or gouged recess at the mould parting line. It usually presents as a ragged seam line near the gap where the seal exited the mould. Its appearance is typically irregular. No tool marks or defects seen by the naked eye are permitted.

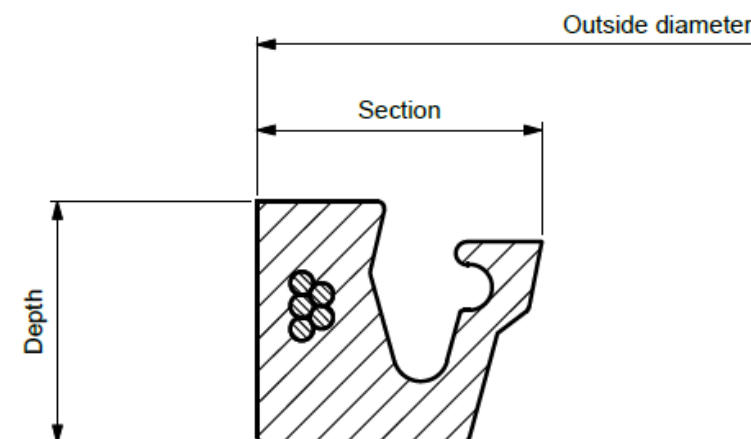
The dimensions highlighted below should be rechecked using the following methods:

Seal to be flat on the inspection bench, top of seal up.

Outside Diameter – *Circumference diameter tape*

Section (After chamfer) – *Vernier*

Depth - *Vernier*
